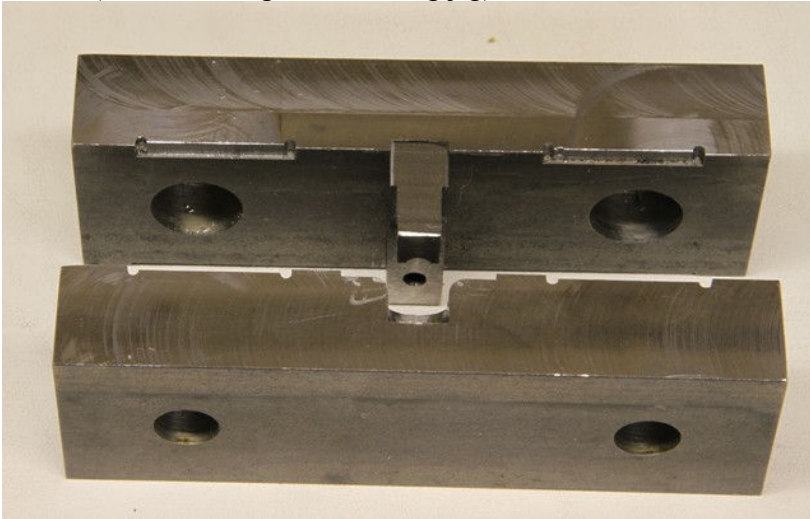
Pic #1 (Rocker arm guide forming jig)

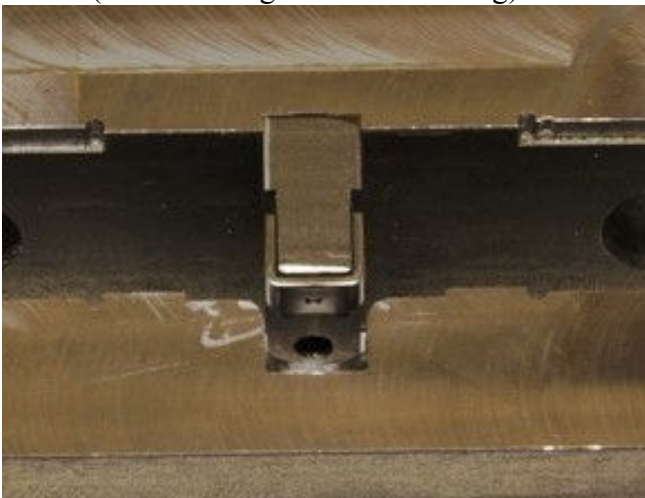
Pic #2 (Rocker arm guide after forming)

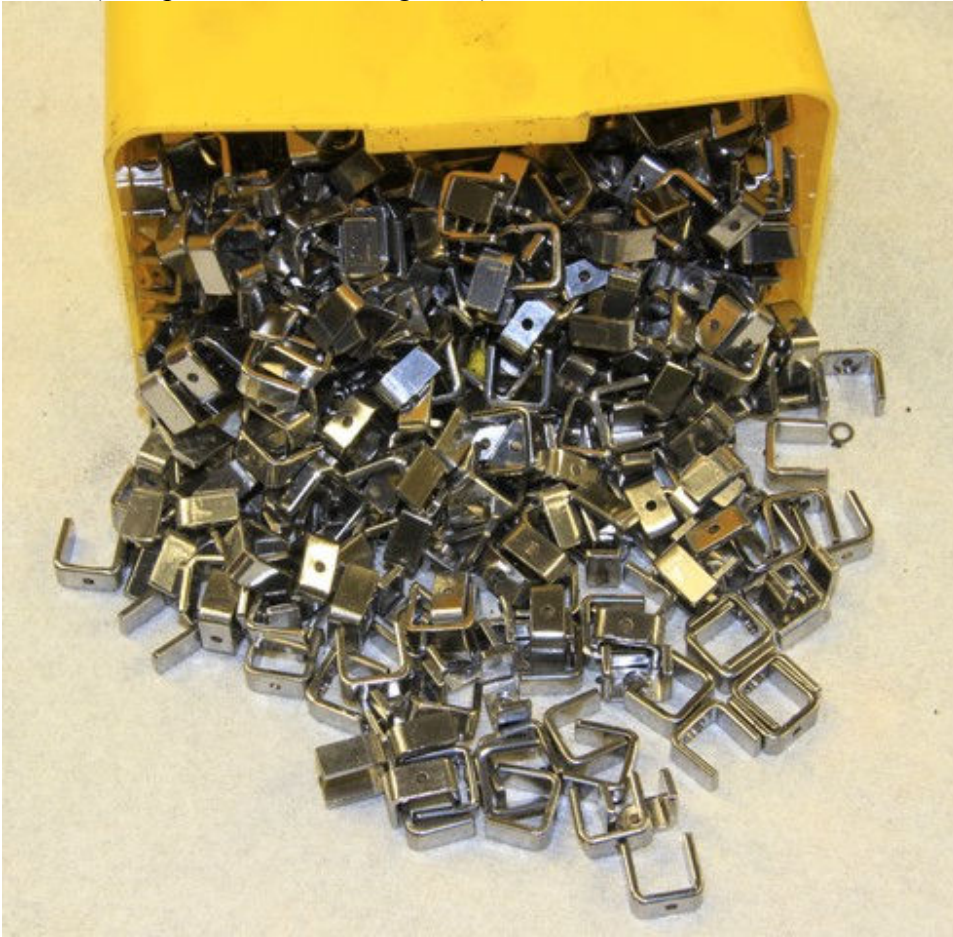
Pic #3 (Completed rocker arm guides)

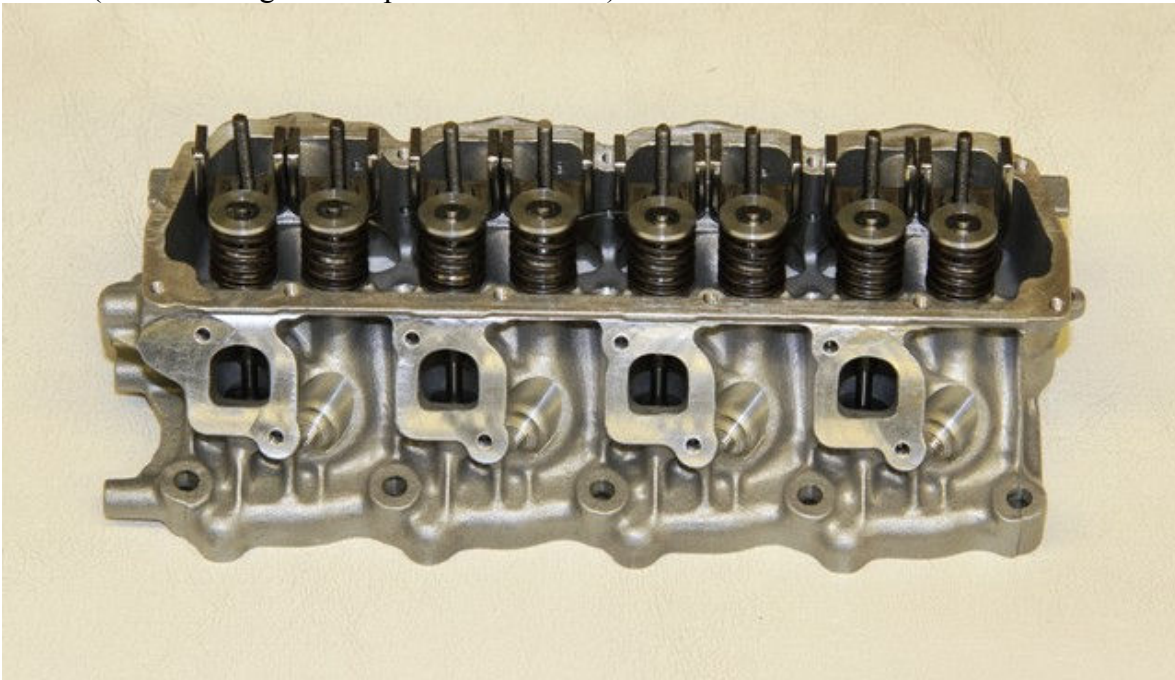
Pic #4 (Rocker arm guides in place on the head)

Sorry for the delay everyone, but I have just completed two weeks of “hell”. It all started with the new pushrod guides. After installing the heads on several engines, I noticed that there seemed to be too much side play at the contact point where the rocker arm touches the top of the valve. If you remember, I was very careful to make the pushrod guide plate with very close tolerances. The thickness of the material was also increased to help eliminate movement. Obviously there needs to be some clearance not only for hole in the pivot but also where the pivot contacts the inside of the rocker arm. Furthermore there is a mechanical advantage which allows for the tip of the rocker arm to move further than the heel. Is everyone still with me? Unfortunately this mechanical movement also allows for an exaggerated lateral movement of the tip. After some serious time and several sleepless nights, I went back to the prototype design and improved on it. I needed to make a forming jig which would insure every new bracket was identical. As you can see from the pictures the new rocker arm alignment bracket does not allow any lateral motion! In other words, there is no way the tip of the rocker arm can pivot from side to side. So, all the pushrod guide plates were removed and the new alignment brackets installed. The old pushrod guide plate was an improvement when I put it in - and an even bigger improvement when I took it out.

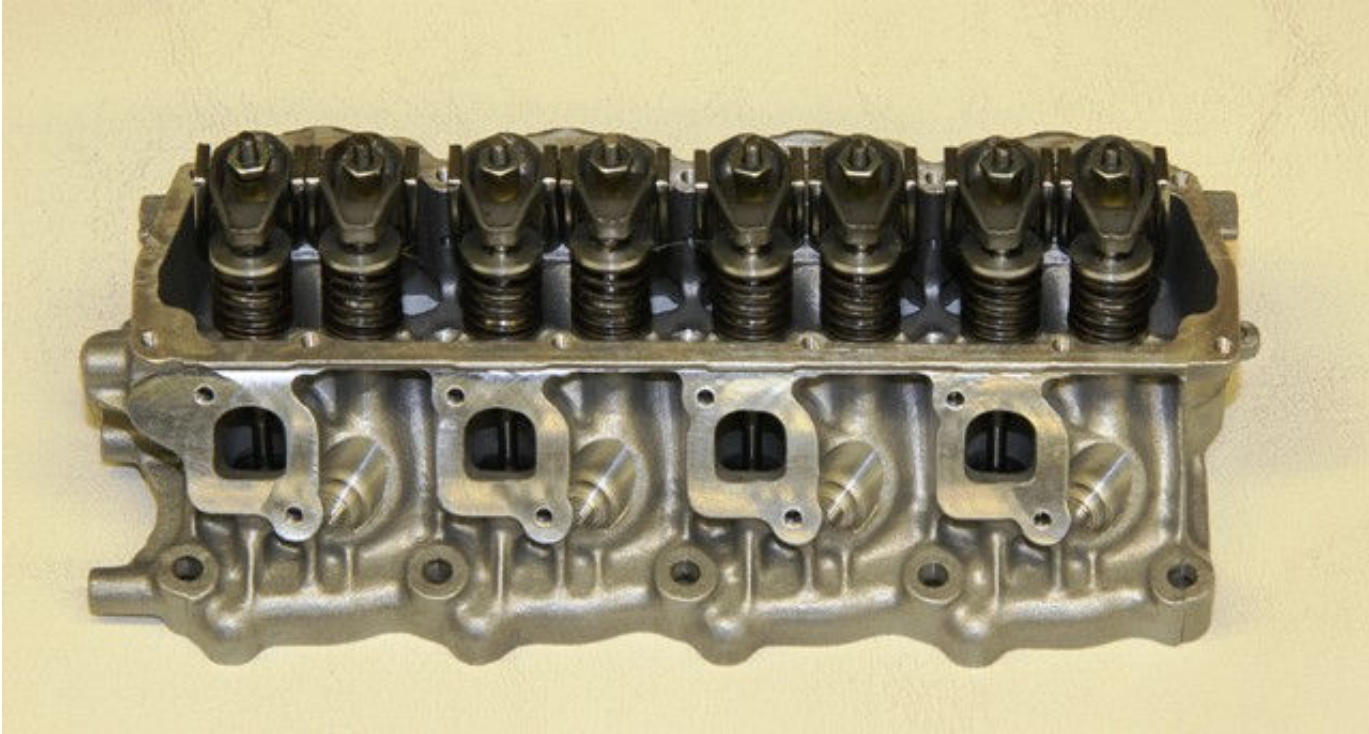
Pic #5 (Rocker arm guides with sample rocker arms in place)

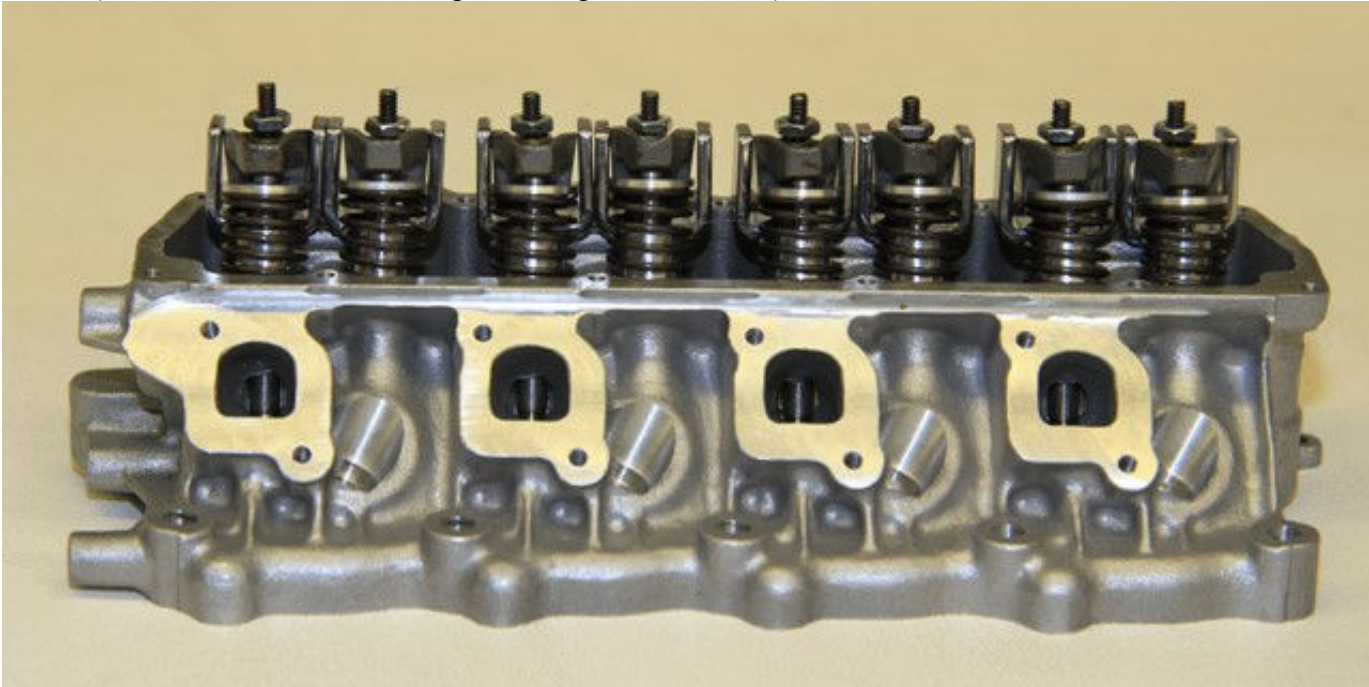
Pic #6 (Notice how rocker arms align with top of each valve)
