For what it is worth, I started this update the day after Christmas. It is now January the 7th. As the first run on engines nears completion, the stack of finished parts gets higher each day. Testing is continuing on some of the finished engines and although there were a couple areas which needed some changes or modifications, the net result is that the engines are running GREAT! The new air cleaner halves can be seen in picture #1&2. Notice the machined groove which allows for the filter element to be held in place. Each piece is then media blasted to make that great satin finish. Speaking of filter elements, I have done extensive sampling and testing to get the perfect material. It must have very little air restriction but still allow for microscopic particles filtration. Not only is it a great product but allows for the element to be cleaned with a little cool soapy water.

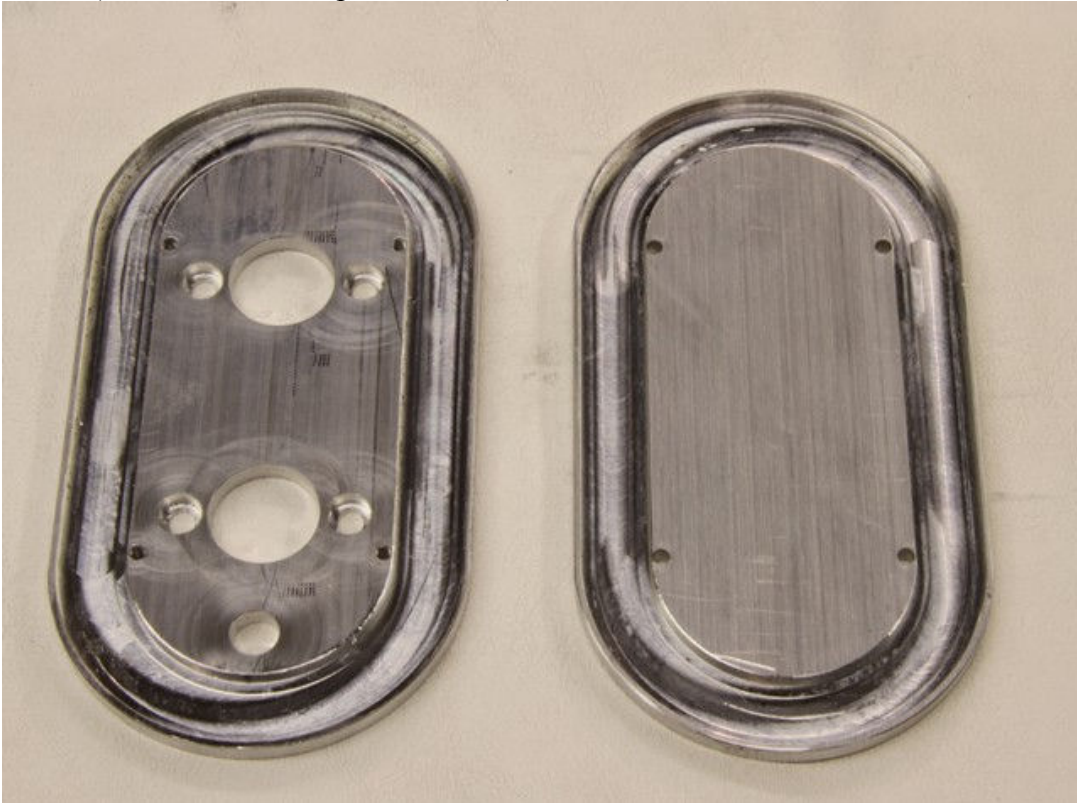
Pic #1 (New air cleaner top and bottom)

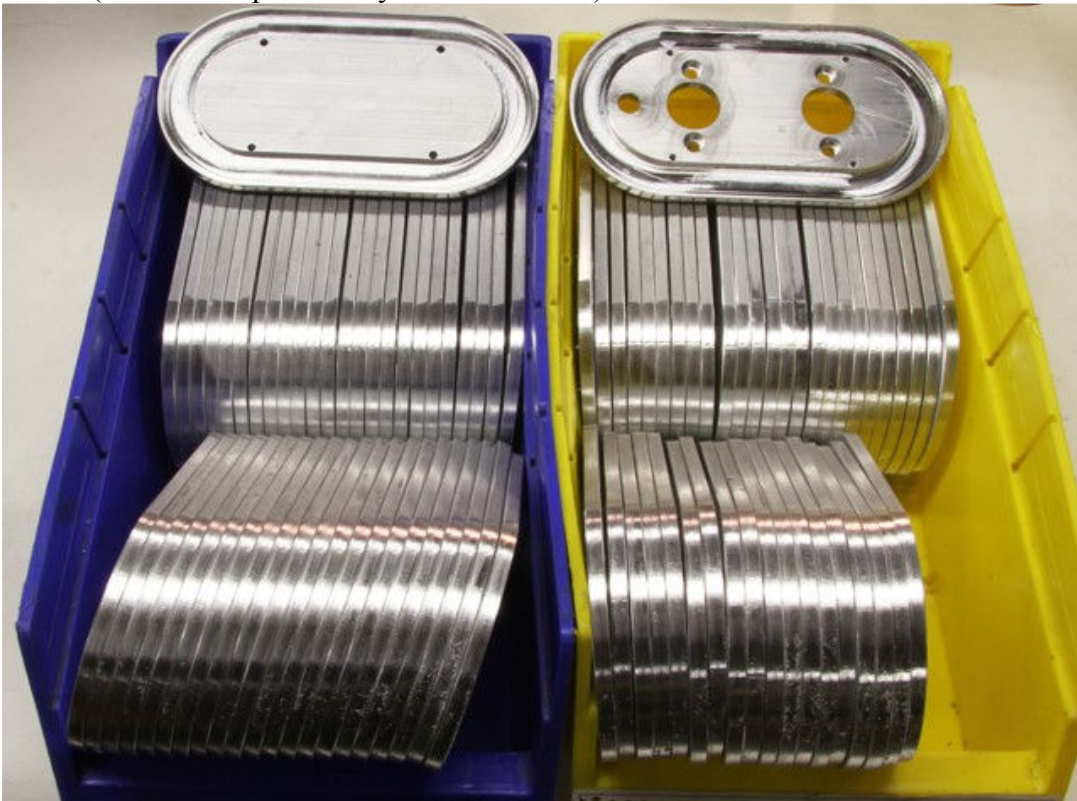
Pic #2 (Air cleaner parts ready for media blast)

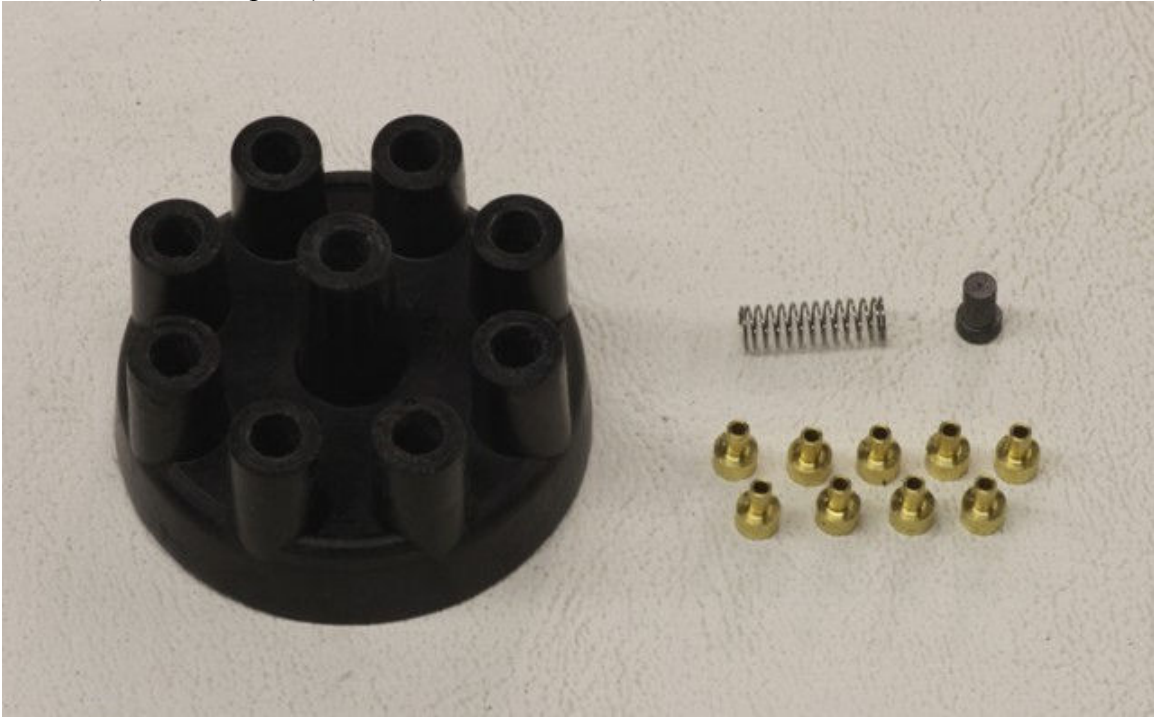
Pic #3 (Distributor parts)

The distributor caps are now finished and ready for installation. Picture # 3 shows just how many parts go into each cap. The very small gray part in the upper right hand corner is actually the graphite center electrode, which is spring loaded and maintains contact with the rotor in the center of the distributor. Once all the wires are cut to the exact length and installed into the cap, then each end has the metal spark plug contact crimped in place. This is followed up with a spark plug boot to cover the metallic end. Keep in mind; distributor cap has 9 wires, 9 brass contacts, 8 metal ends, one graphite contact, one spring, and 8 boots. If you multiply this, times 40 engines, it is easy to understand the difficulty of building a production run of engines. Can you imagine how many parts will be needed for my next run of 125 engines? I am exhausted just thinking about it.

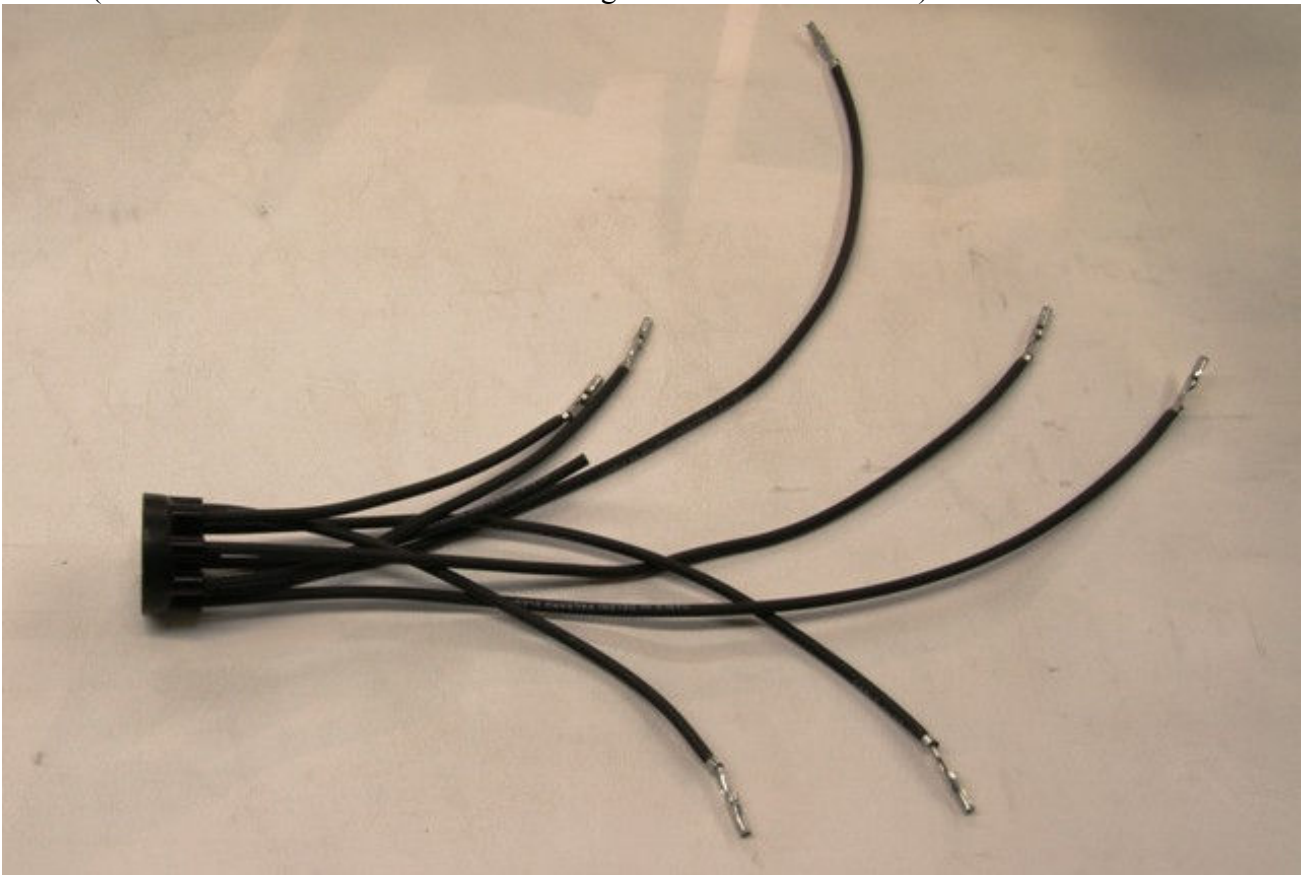
Pic #4 (Distributors with wires installed waiting for boots to cover ends)

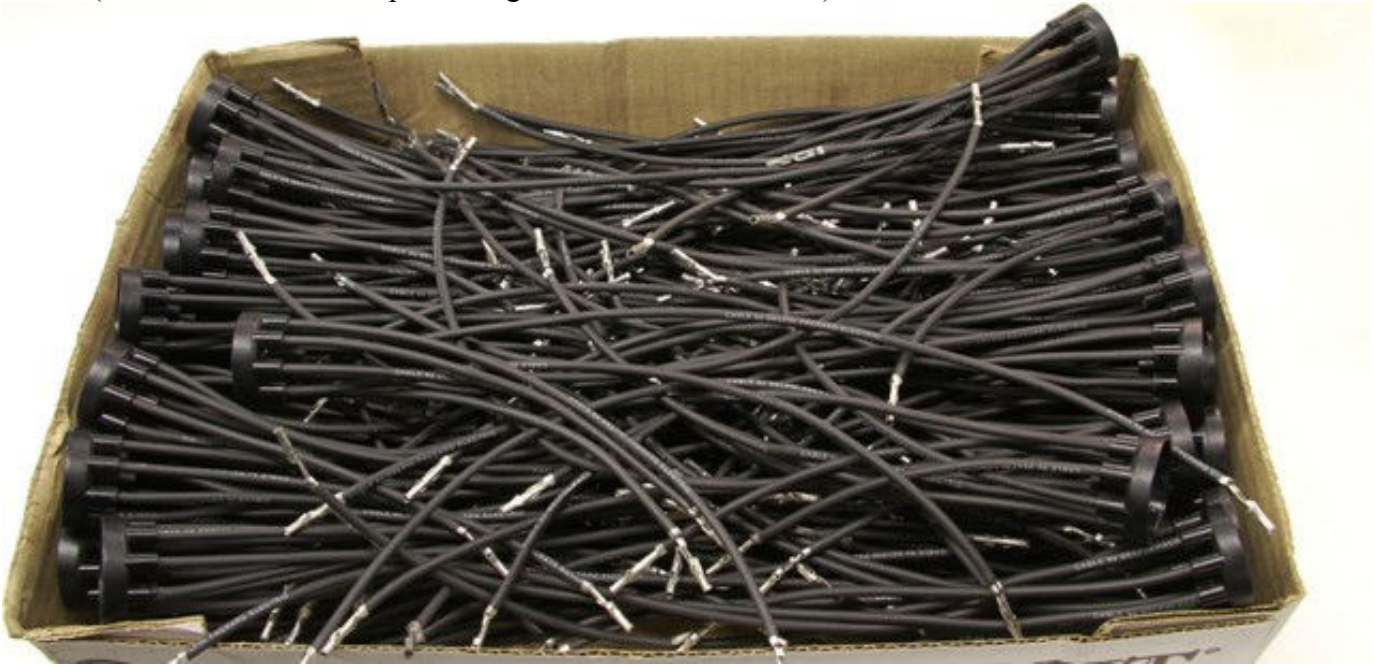
Pic #5 (Finished distributor caps waiting for boots to cover ends)

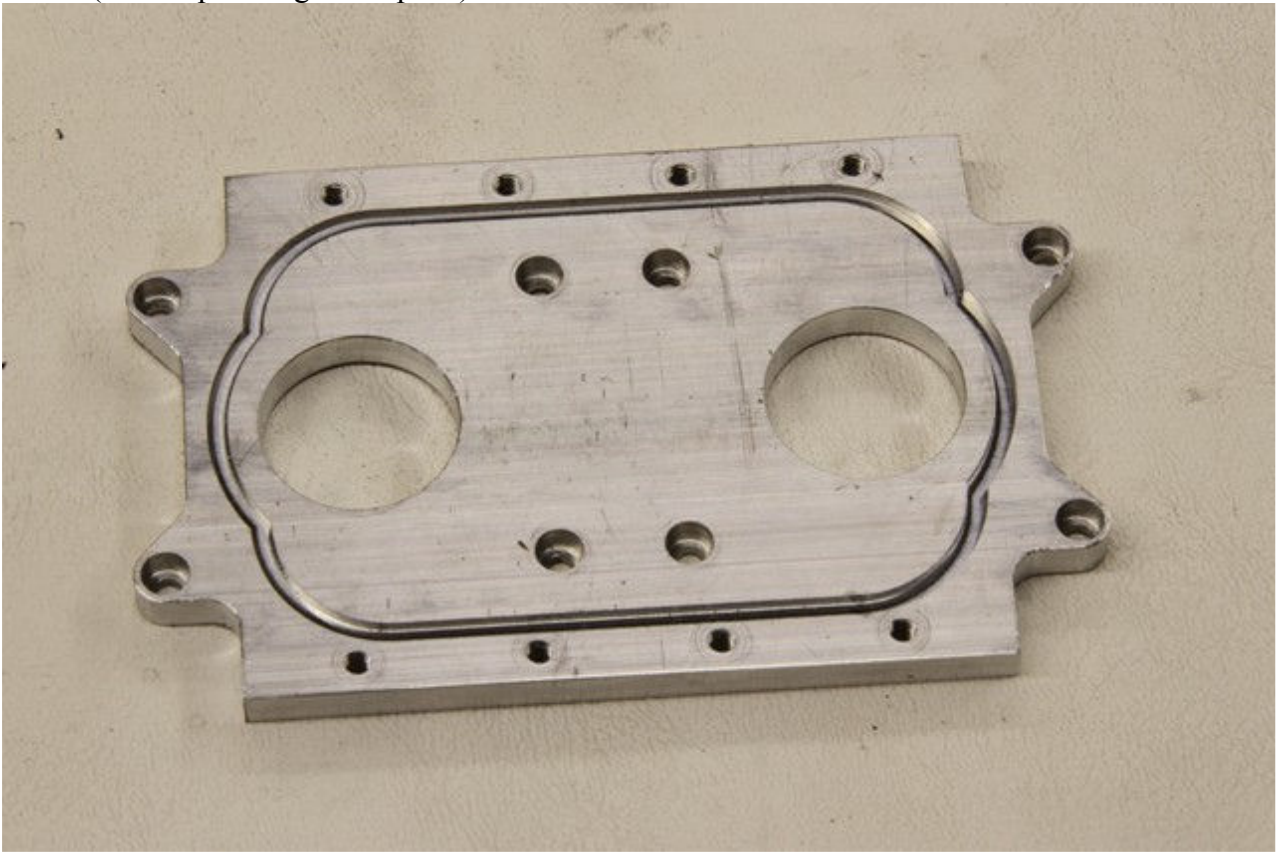
Pic #6 (New supercharge base plate)

The base plates for the supercharged were significantly altered and ready for installation, as are the normally aspirated adaptor plates.

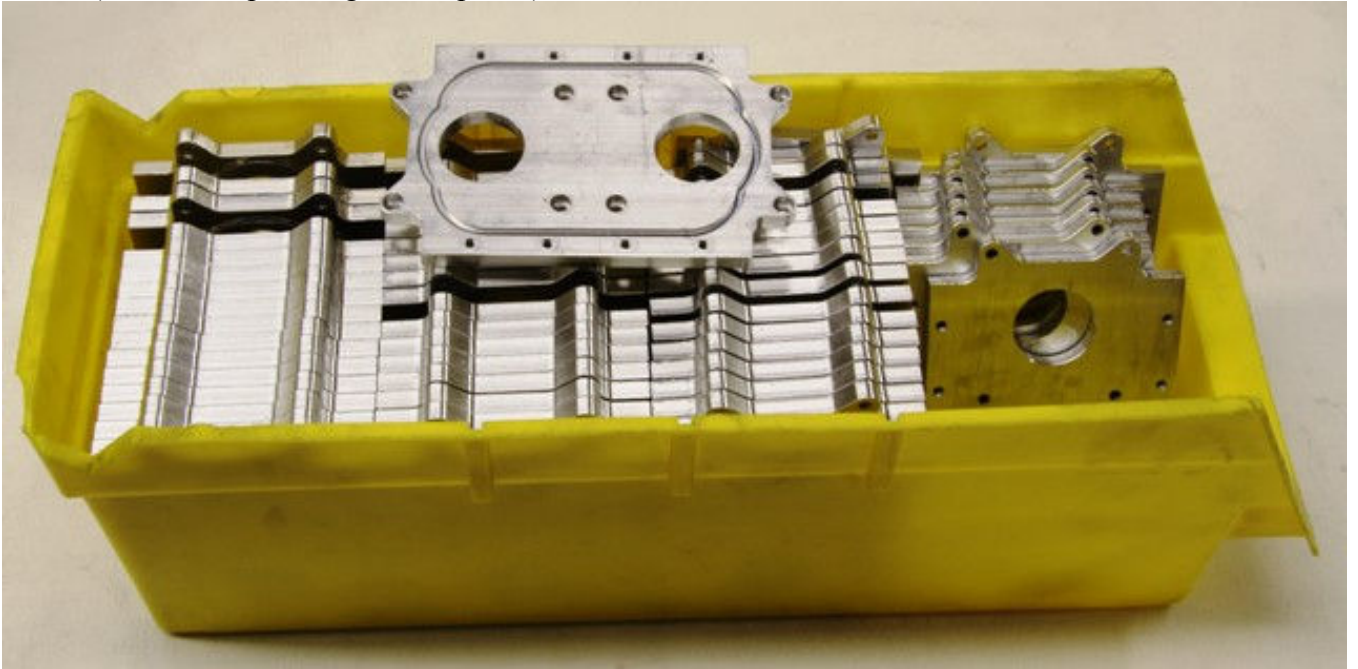
Pic #7 (Finished supercharger base plates)

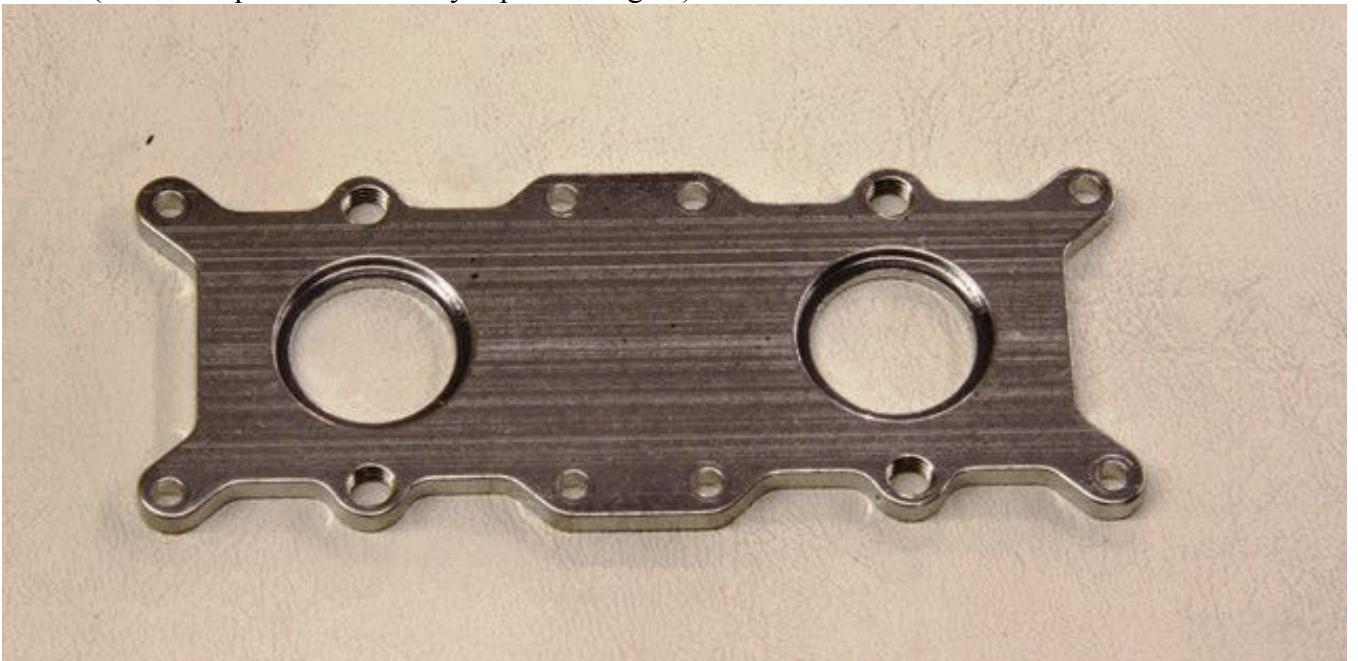
Pic #8 (New base plate for normally aspirated engine)

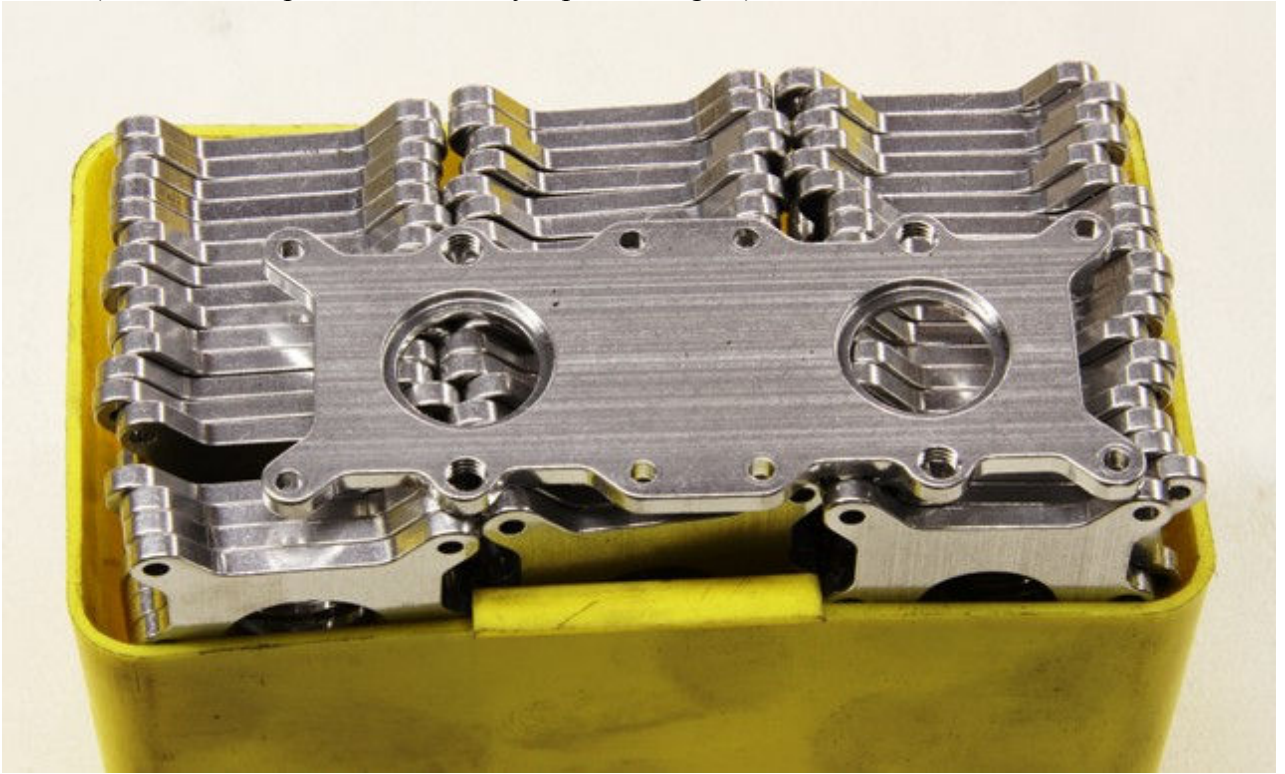
Pic #9 (Finished base plates for normally aspirated engine)

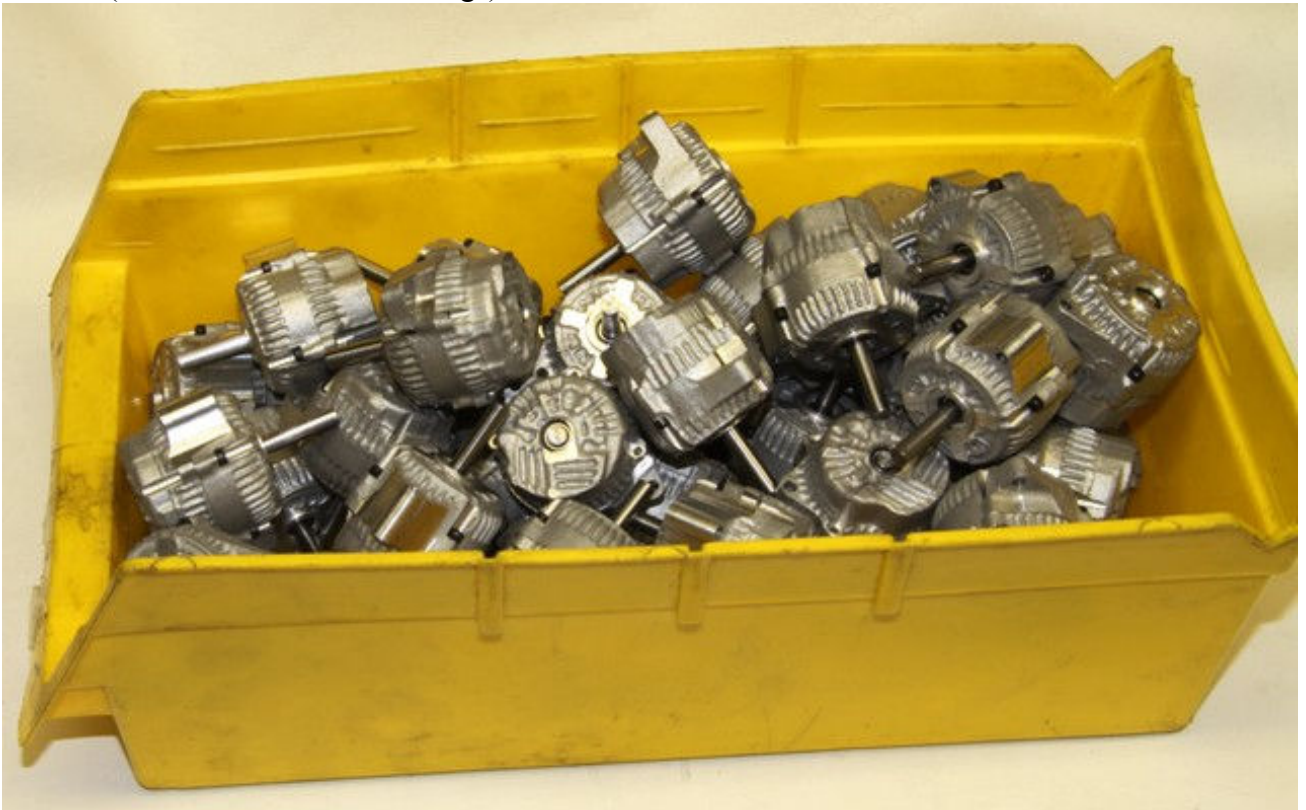
Pic #10 (Finished Alternator housings)

The alternator halves, bearings, shaft, and internal spacer, have been assembled – which make a completed unit. All they need now is to have the toothed pulley put into place.
