It is 6:30 Sunday morning and after getting an extra hour of sleep, it seemed like a good time to give everyone the latest update. As you can see from the first picture all of the blocks have the crankshafts installed, along with the connecting rods and pistons. Before you take a count, one block is missing and was sent to a customer who wishes to polish everything prior to assembly. This was a major undertaking and now everything can be attached. It is comforting to know that all the components went together very smoothly. The next operation is to install the camshaft with the front thrust plate - then the rear camshaft cover. When the camshaft is determined to rotate smoothly and all clearances have been checked, it is then removed and all surfaces are coated with a special "assembly lube" and then re-installed. This lube stays in place and is very beneficial to reduce friction on the initial start-up. The lifters will go in next, followed by the head gaskets, heads, pushrod guide plate, and finally the rocker arms and pivots. This should keep me busy for the next week or two. The front of the engine in picture #2 shows the timing gear, distributor gear, and distributor gear driv

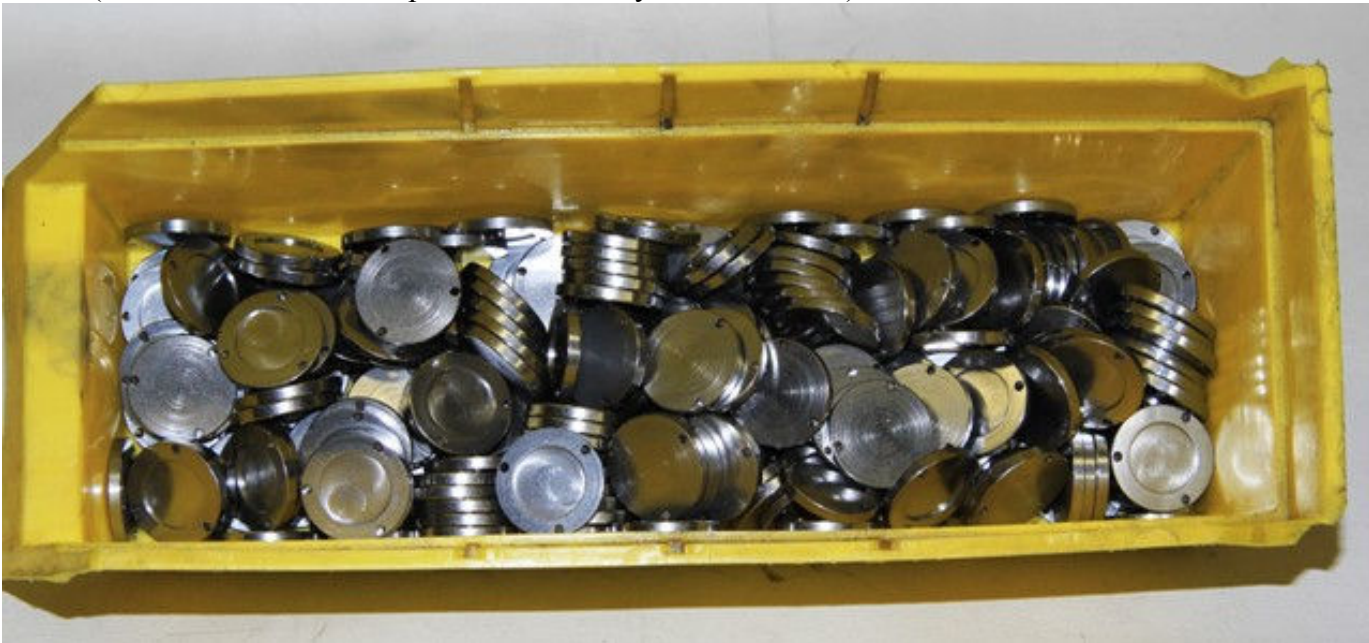
Pic #3 (Rear camshaft covers – polished and ready for installation)
