(1 June 2008)

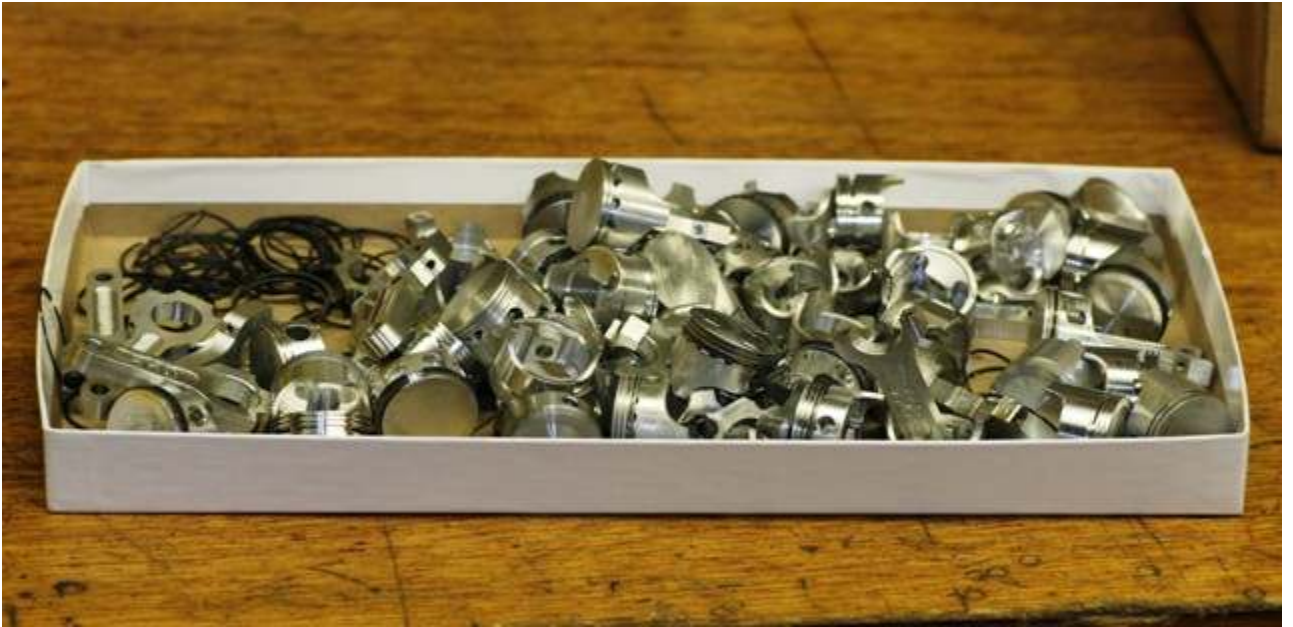
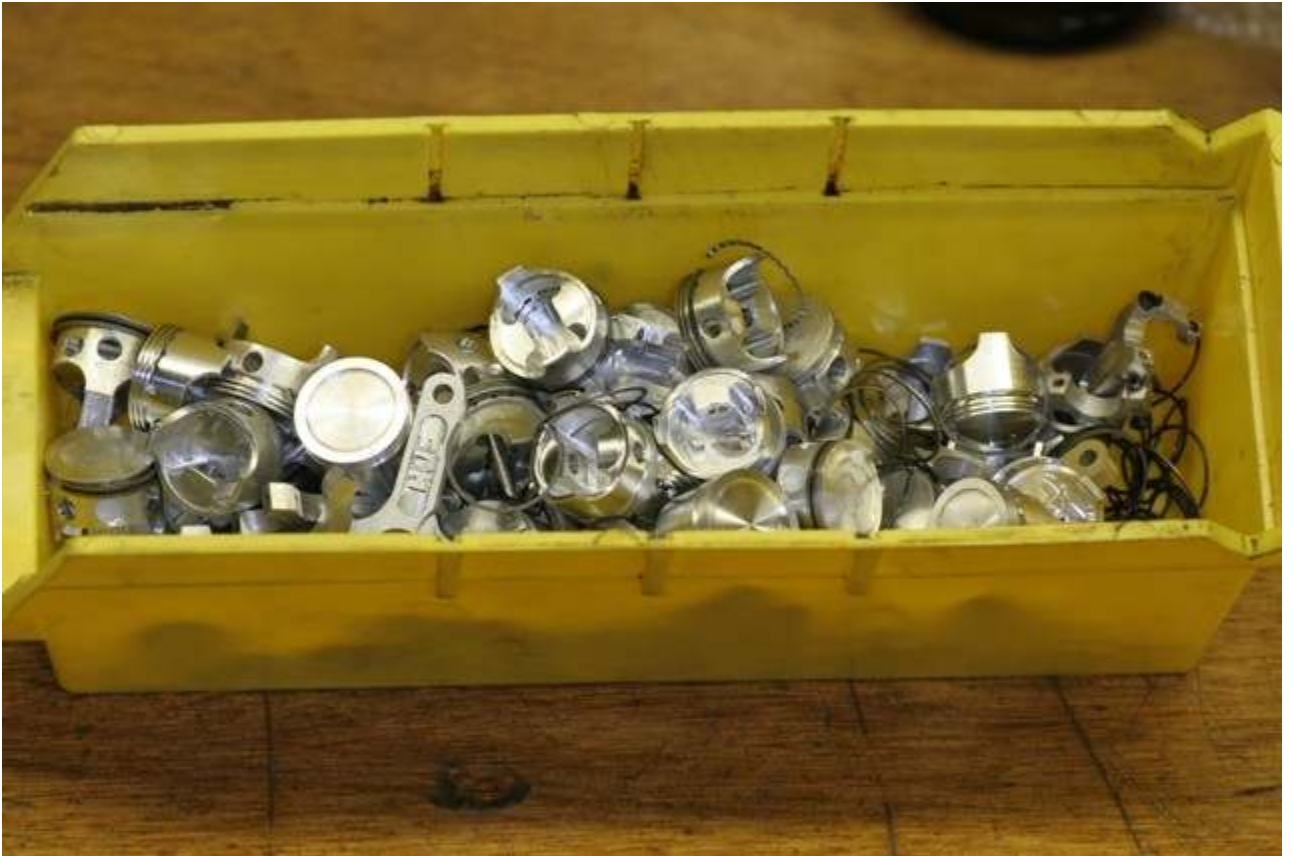
The first two pictures are boxes of rejected pistons, rings, and some connecting rods. It isn't just a matter of making new pistons and testing them. This process is extremely complicated, very time consuming, and can be a mental challenge, to say the least. The following is an idea of just what must be done;

1st. The program is written, checked, the CNC lathe setup, samples are made, the program changed to accommodate different ring configurations, and finally the piston blanks are machined.

2nd. The piston is placed on its side, in a special holding jig for the wrist pin hole, and then center drilled, drilled, and finally reamed.

3rd. They are then inverted and the CNC machining center machines the interior and creates the piston skirts.

4th. They are de-burred and the oil return holes are drilled on the lower oil ring groove.
