(10 Dec 2007):

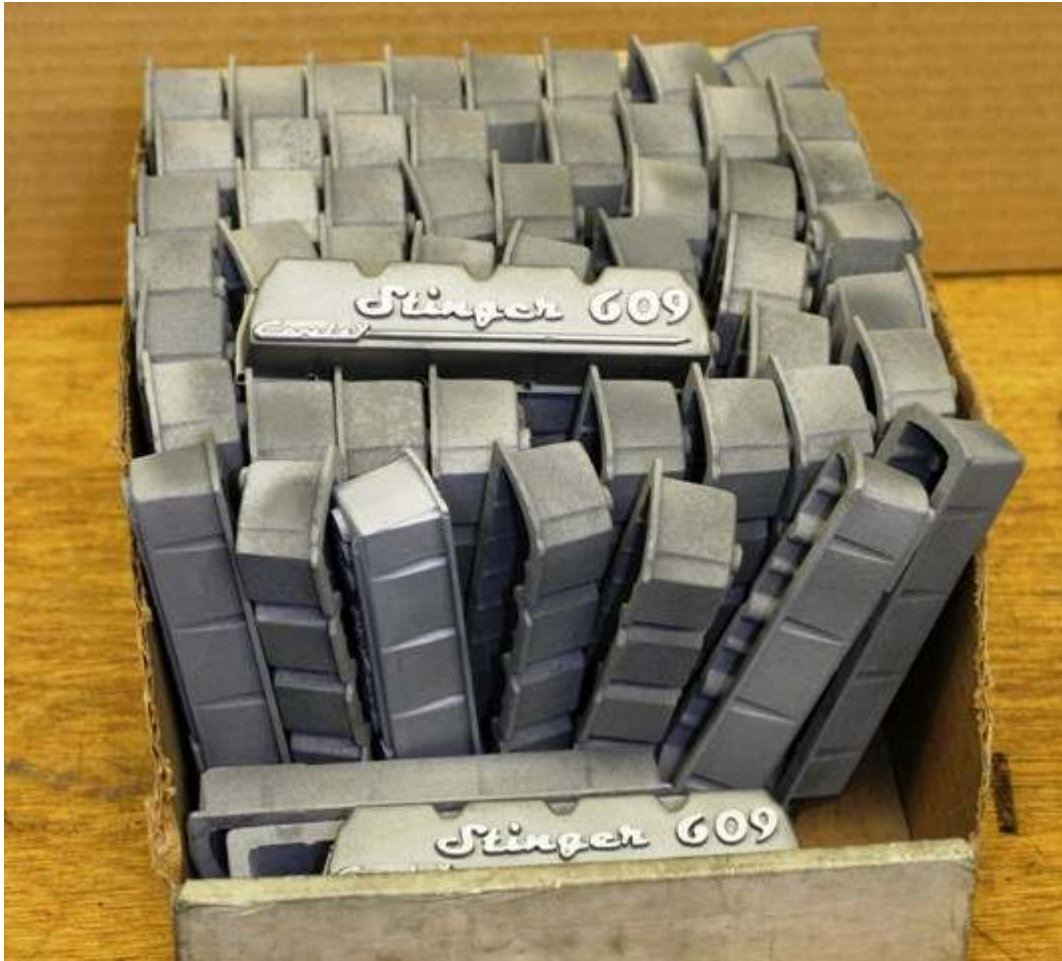
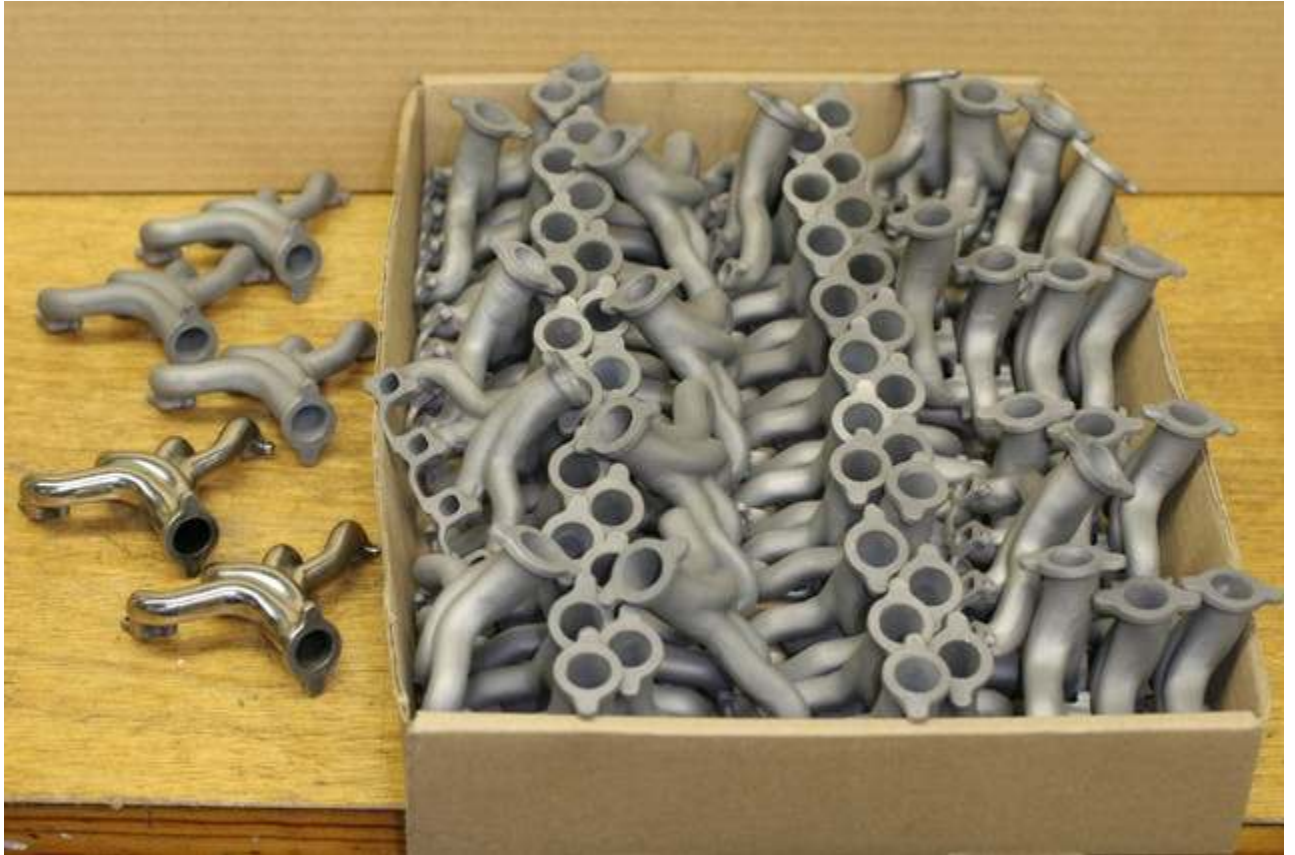
As you can from the top two photos, the castings for valve covers and exhaust manifolds are in stock. There are several trays of the same parts. Once all of the casting have arrived, they will be sent out to be heat treated. The molds for the exhaust manifolds were very difficult to make because of the parting line that is needed. For those of you who are not familiar with a "parting line", it is a line around each part which allows the wax pattern to be able to be removed without breaking. The exhaust manifold is a complicated part, with no straight lines. The core has the same problems. Oh, one more thing, wax and metal shrink and different rates and the size each master parts must be made to allow for this shrinkage. If everything is not calculated correctly, then parts do not align. So much for the castings, the third picture from the top shows the new oil pump bracket. The one on the left is the prototype, the one on the right, being the finished item. What looks like a simple item, is in fact, quite complicated. The valve body (far right), not only allows oil into the filter, but includes an adjustable pressure relief. This

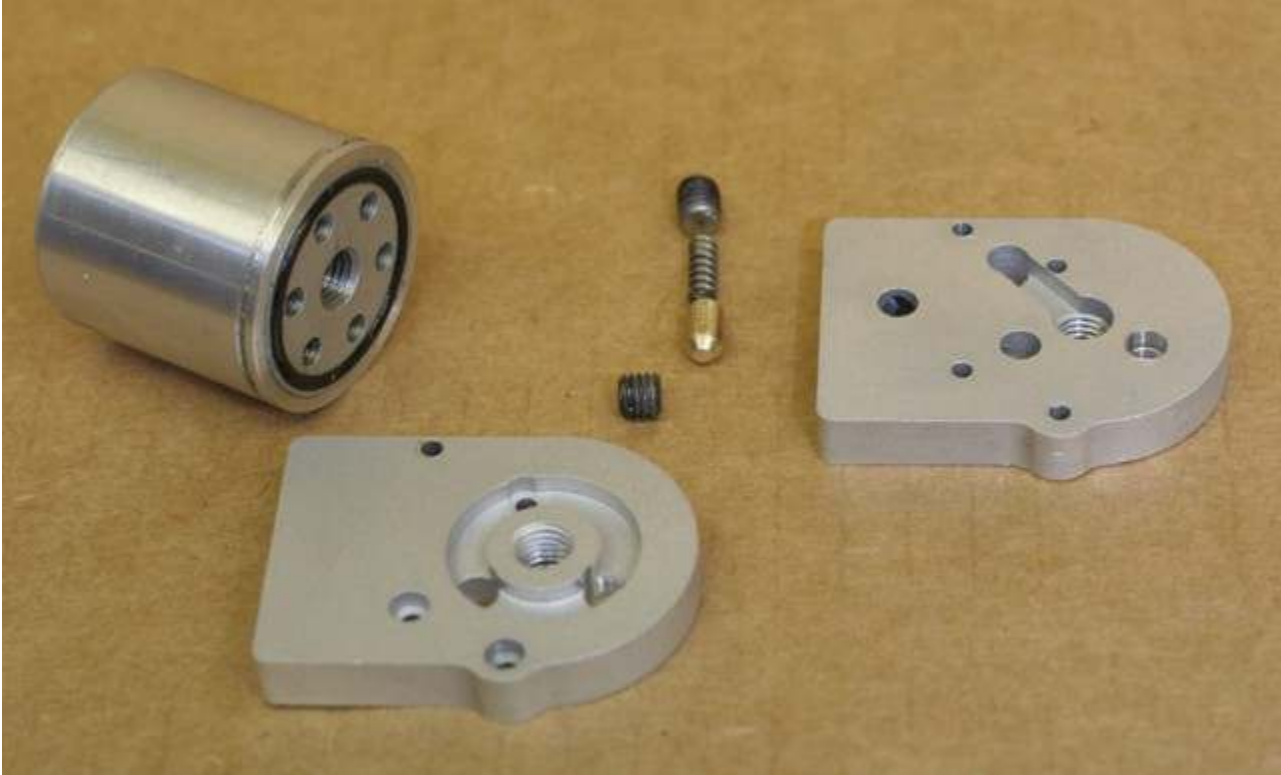
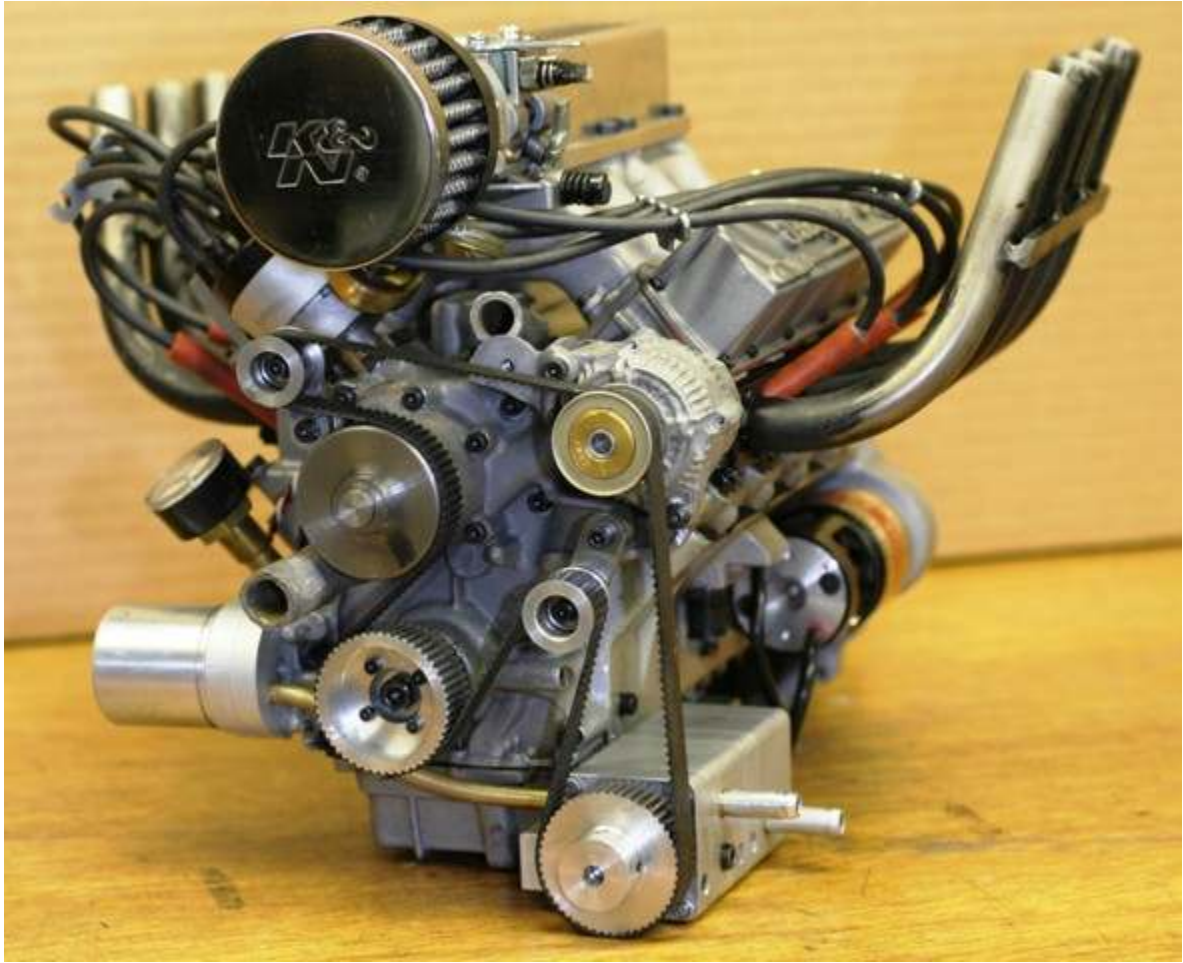
is extremely important, because of the high pressure the new pump is capable of producing. The fourth picture is the finished shows a close-up of the entire unit. Once again, many hours when into the development and testing. Because of the accuracies that are needed for this part, the CNC programs had to be triple checked. The bottom two pictures show the new oil filter bracket installed on the engine. You will also notice a "new look" for the front of the engine. At first glance you may not see the difference, but if you look at my home page, you will see the changes. The modifications were made after several of my customers had made a comment about the aluminum piece that supported the lower idler, looked out of place. After about three weeks of work, I feel that the change was justified. There is an old saying that goes " you cannot see the forest because all the trees are in the way". Until it was brought to my attention, I really did not see the obstacle. What may look like a simple change, took a tremendous amount of time and CNC programming. If you look closely the two idle pulleys were changed and incorporate a flanged on either side to make sure the belt stays in the center. Not only these changes, but any changes must be made before a lot of parts are cast, machined, and in placed in stock. This could be a very expensive proposition. This is why I try to explain that sometimes things take longer than anticipated and no matter how much you plan, it is sometimes difficult to schedule the amount of time that is needed for a particular project. This is especially true on a new engine.
