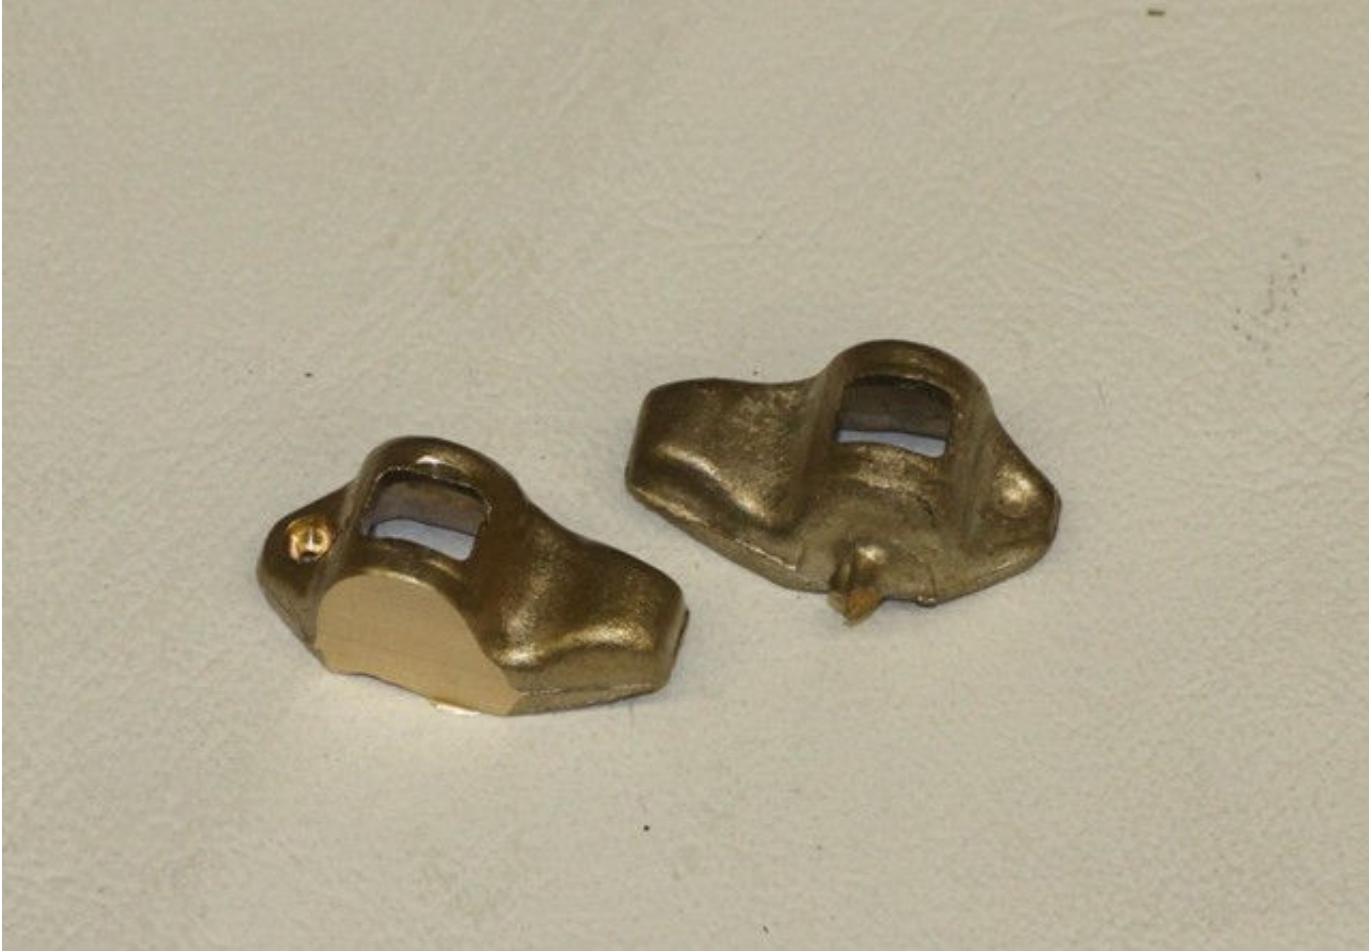
Pic #1 (Rocker arms – before on right, after on left)

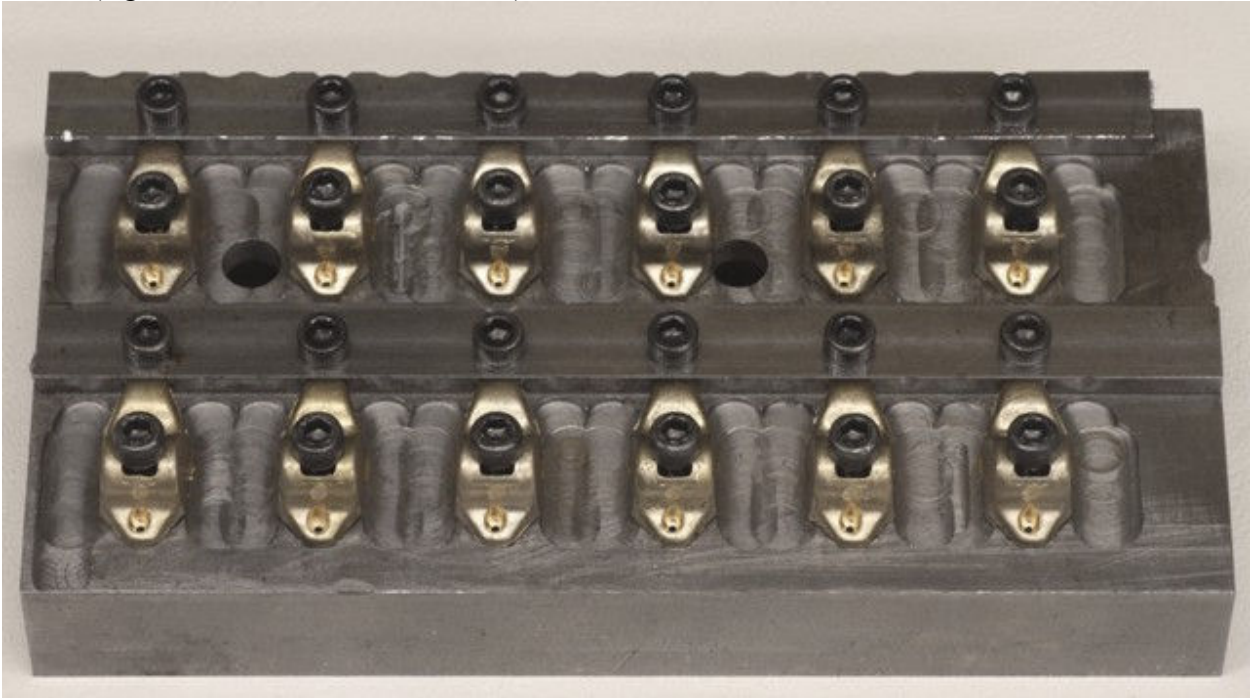
Pic #2 (Jig used to machine rocker arms)

It has been over two weeks since my last update and the last week was not to be believed. Everything started out well, but soon went from bad to worse. After spending a couple of days making the special jigs needed to do the rocker arms (Pic #2) the CNC program was modified and after destroying 3 carbide taper end mills, at a cost of over \$60.00 each, the rest of the week was spent completing the rocker arms. As I have stated on several times, normally two jigs need to be made. Too much time is lost when only one jig is used! Picture #1 shows the before and after. Unfortunately you cannot see this but on the bottom side of the rocker arm I needed to use a .093 Ball end mill to make a perfect receptacle for the mating surface on the push-rods. Keep in mind, these are castings which are quite small and extremely difficult to clamp and hold in place while machining. In addition to the rocker arms, the pivot, which is in the center of the rocker arm, must be machined. This part is even smaller. Take into consideration that there are 40 engines and with 16 rocker arms, there are a total of at least 640 parts that need to be finished. Add to this the same number of pivots and you can easily understand why it is taking so long. Like I said before “machining 1 part or 10 parts is no problems, but when you need hundreds or thousands it is quite evident why special and in most cases multiple jigs and CNC programs must be written.

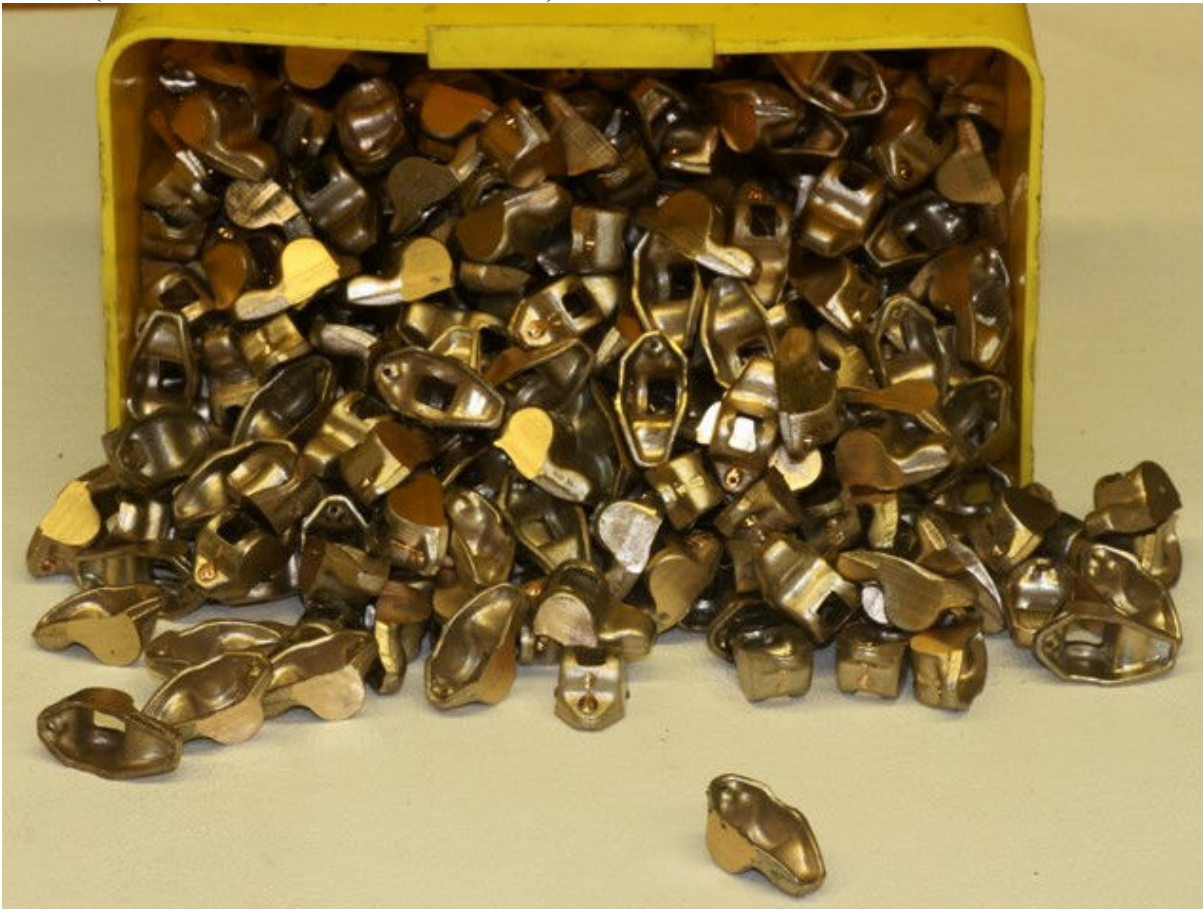
Pic #3 (Partial box of finished rocker arms)

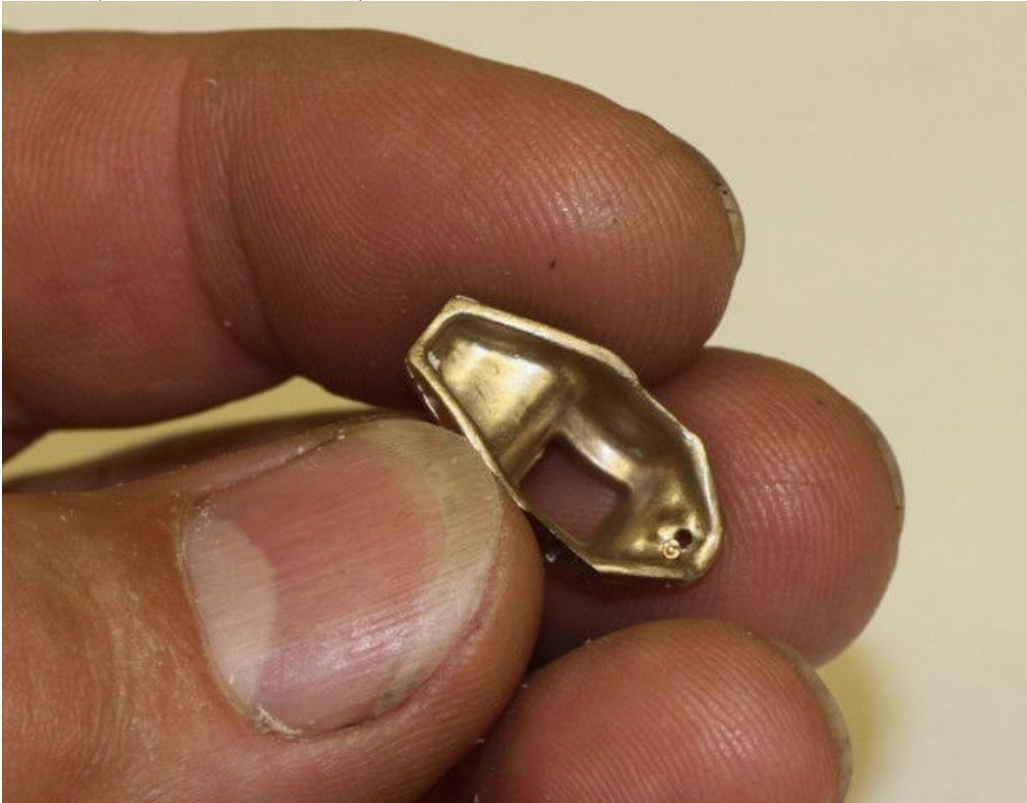
Pic #4 (Finished rocker arm)

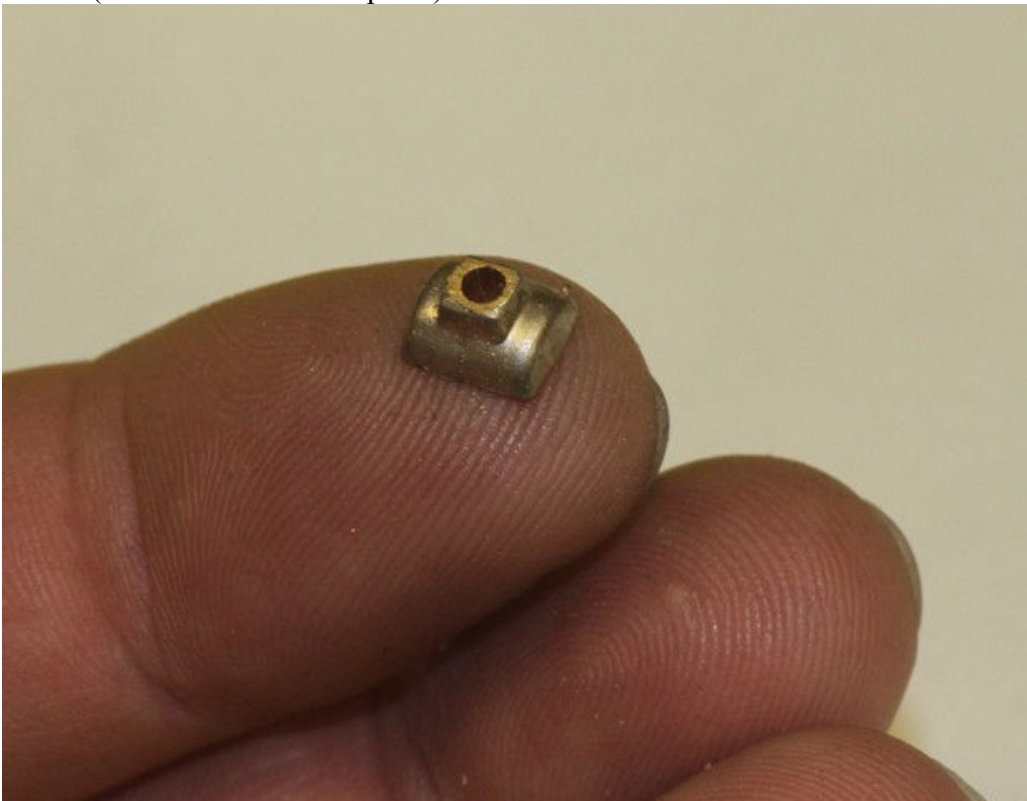
Pic #5 (Finished rocker arm pivot)

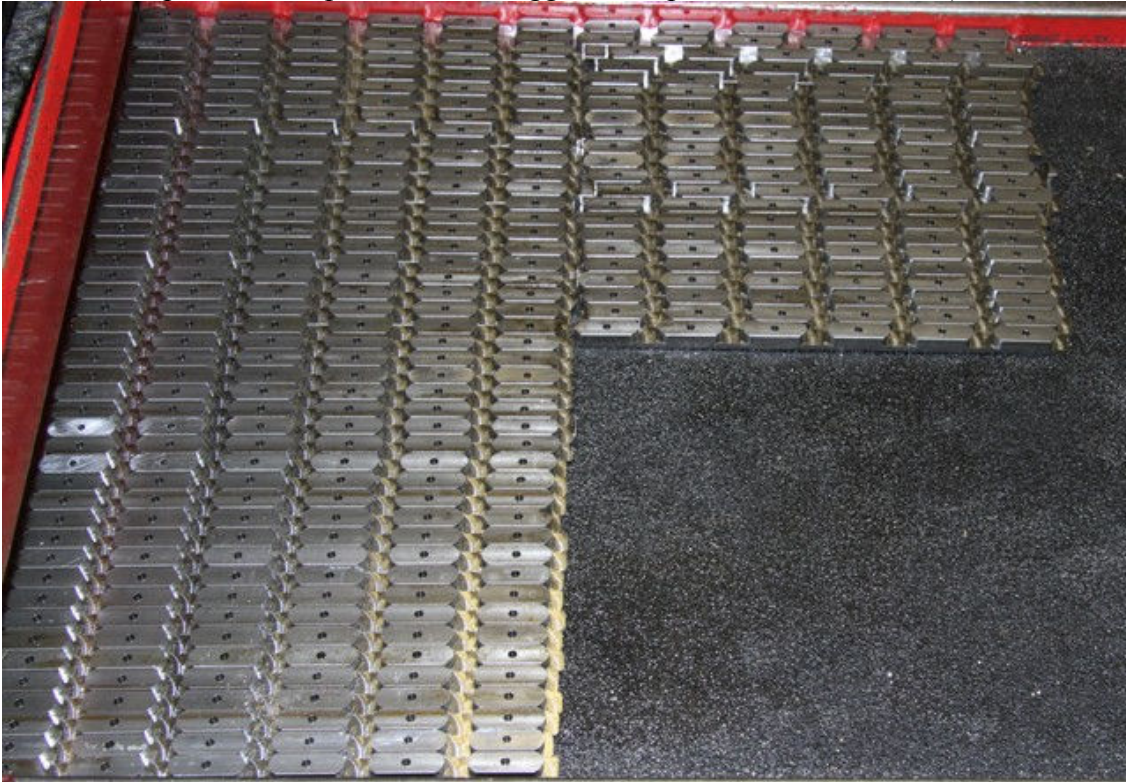
Pic #6 (Completed first operation on "Toggle" clamps for intake manifold)

As you can see from the pictures the toggle clamps are finished and polished. The initial process, machines the contour of 6 pieces, on a of 1/4" square rod and can be seen in picture #6. This piece is then inverted and all extra metal is removed, resulting in a completed toggle clamp.

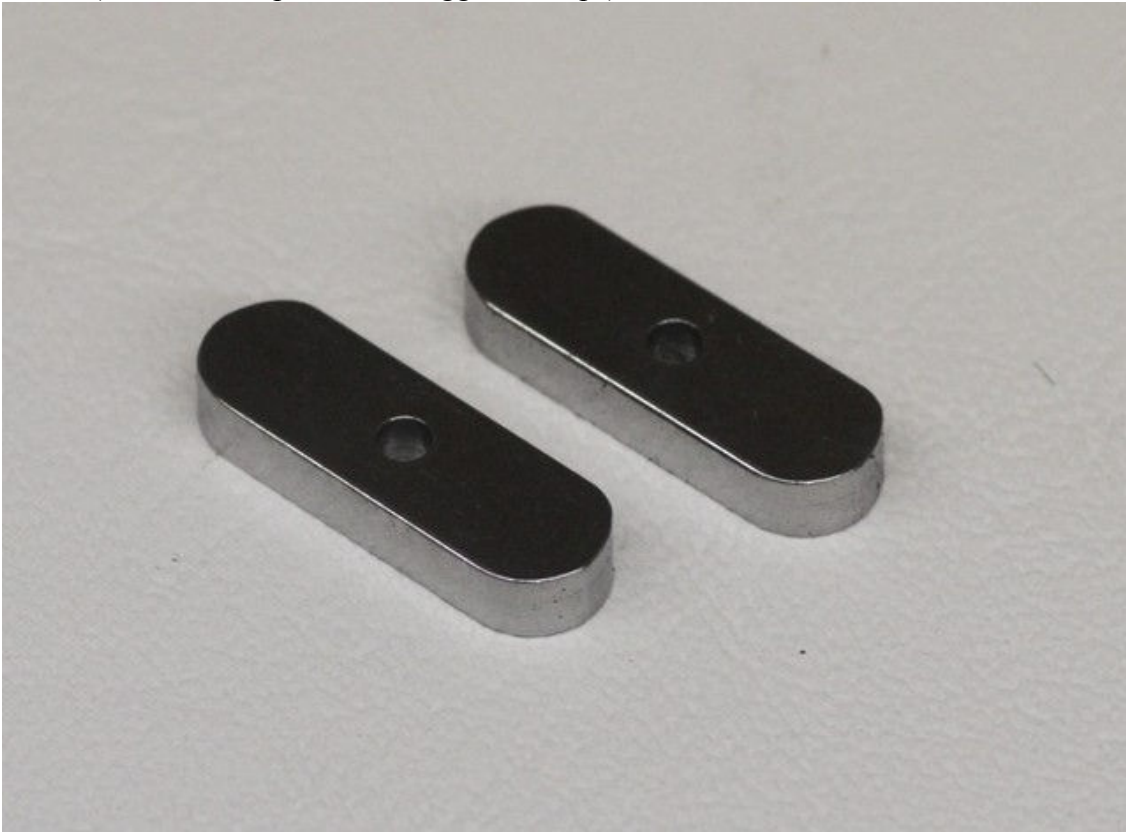
Pic #7 (Finished and polished "Toggle" clamps)

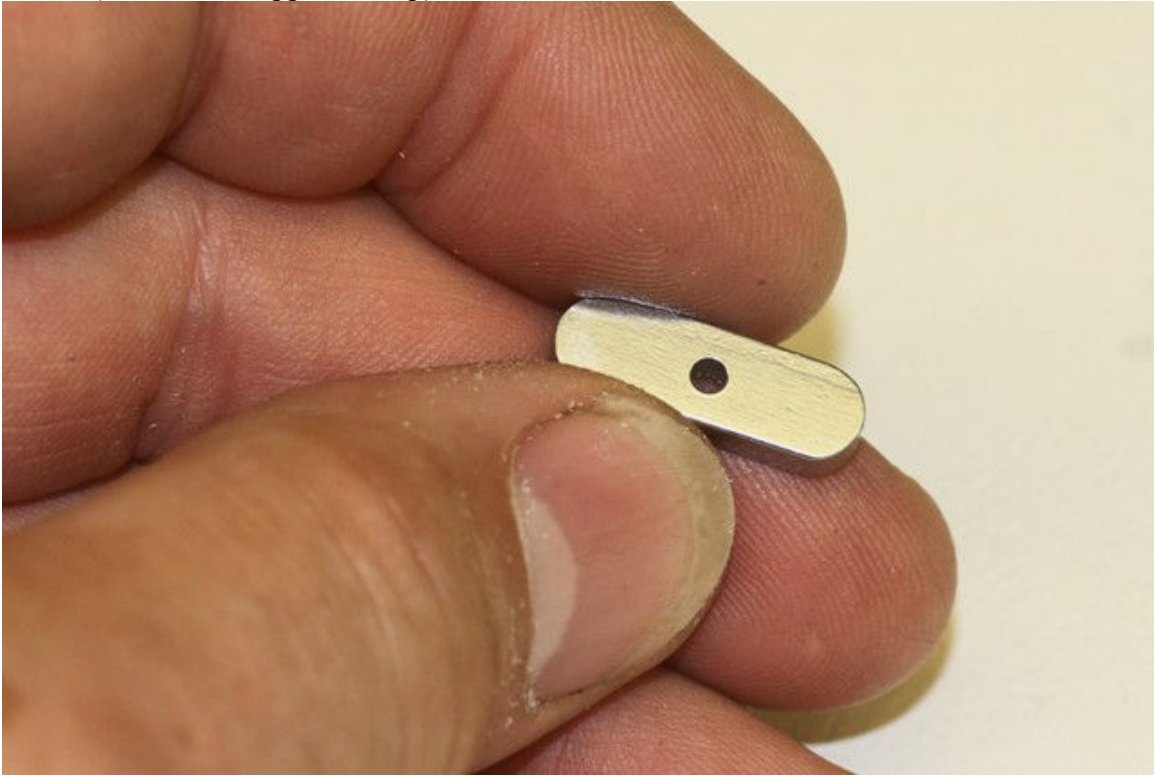
Pic #8 (Finished "Toggle" clamp)

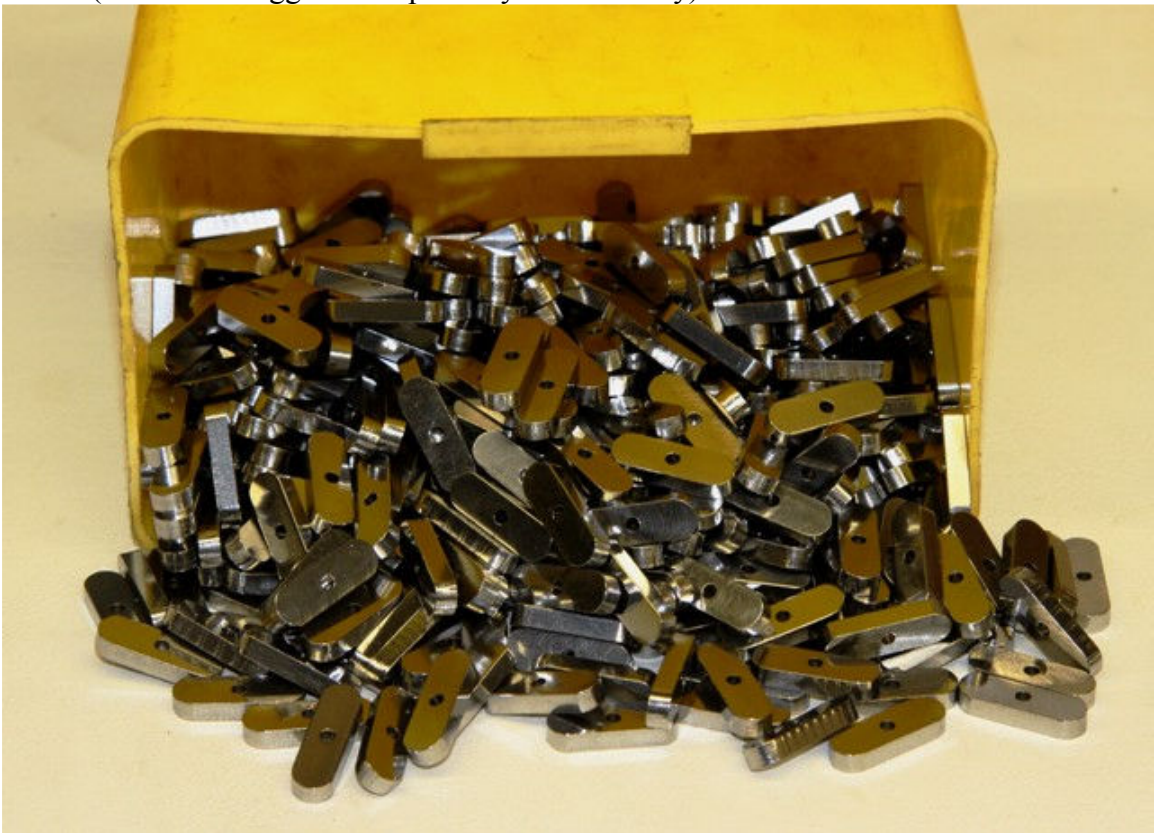
Pic #9 (Finished "Toggle" clamps ready for assembly)
