(29 Jan 2008)

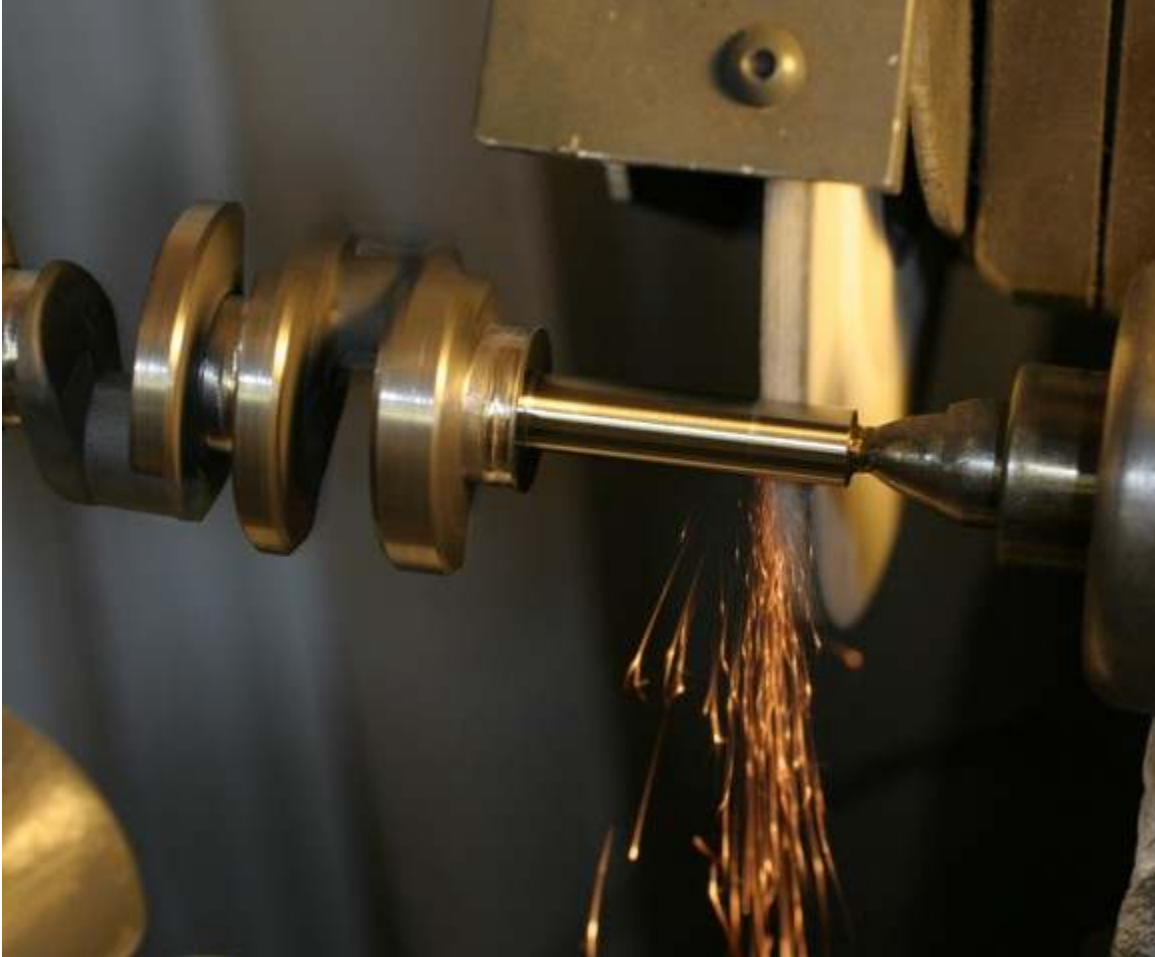
A lot has been happening with the crankshafts but unfortunately few pictures. The last two weeks has been spent in removing all the excess material for the crank throw's. I know this sounds like a broken record, but this time around, a considerable amount of material had to be removed. It just takes a lot of time. For the next series of crankshafts, I will make a new mold so this procedure will not be necessary. It takes a considerable amount of time to make a completely new mold, but the time will be worth the extra effort. A little more "midnight oil". The first pictures shows the small end being finish ground to the exact dimension. I now have two finished ends which can now be place in fixtures, removed, and reinstalled with no loss of accuracy. I cannot over emphasize the importance of this operation. With the crankshafts rough machine to allow for a finish grind, I can not start the long procedure of drilling the oil holes. The second pictures shows the cranks being center drilled for the .062 oil holes that need to be drilled. For

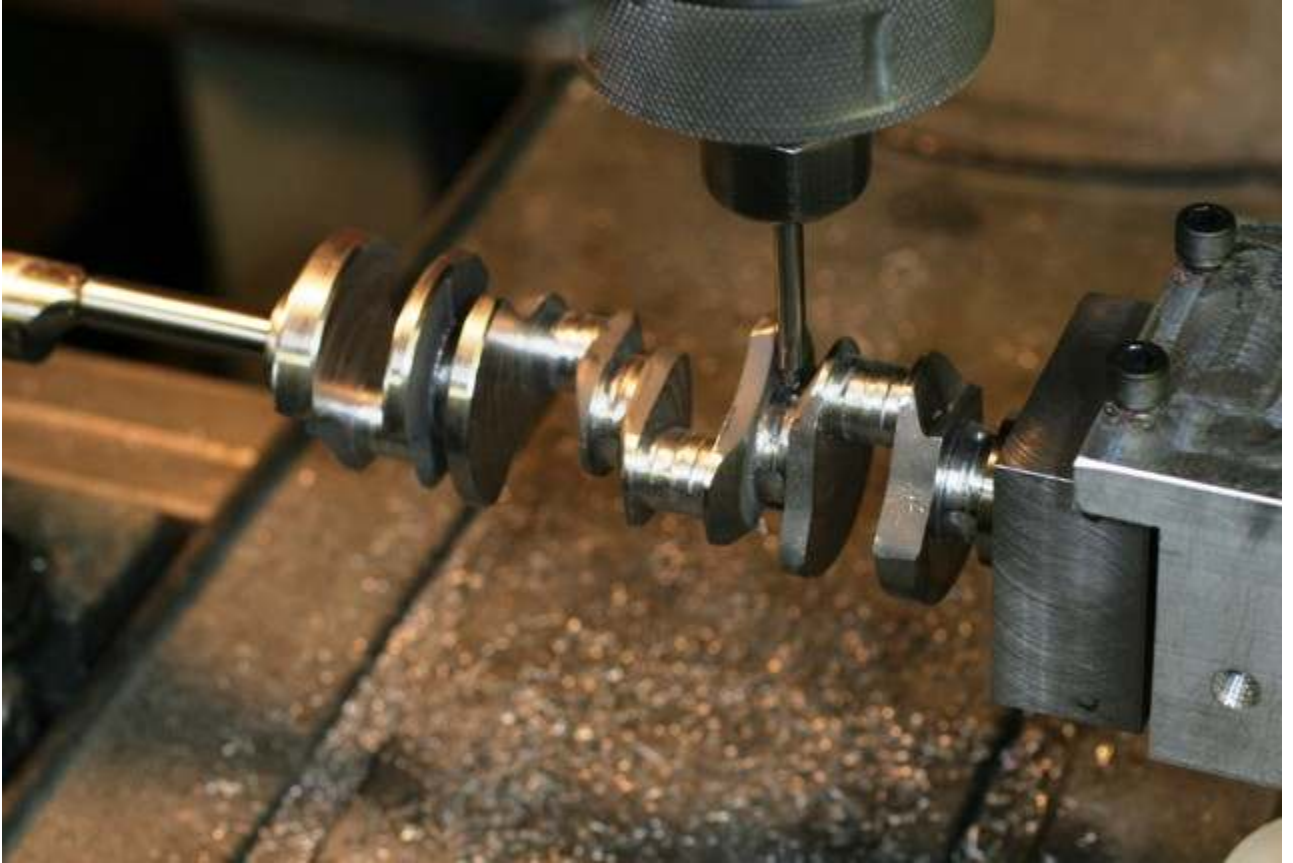
Pic #2

those of you who are not aware, "center drilling" is when a very ridged drill is used to place a small "starter" hole that the next drill can follow without moving from side to side. Once again, it must be in the exact location. With any luck the oil holes should be finish by next week. Then the finish grinding process can begin.
