● 25 February 2009

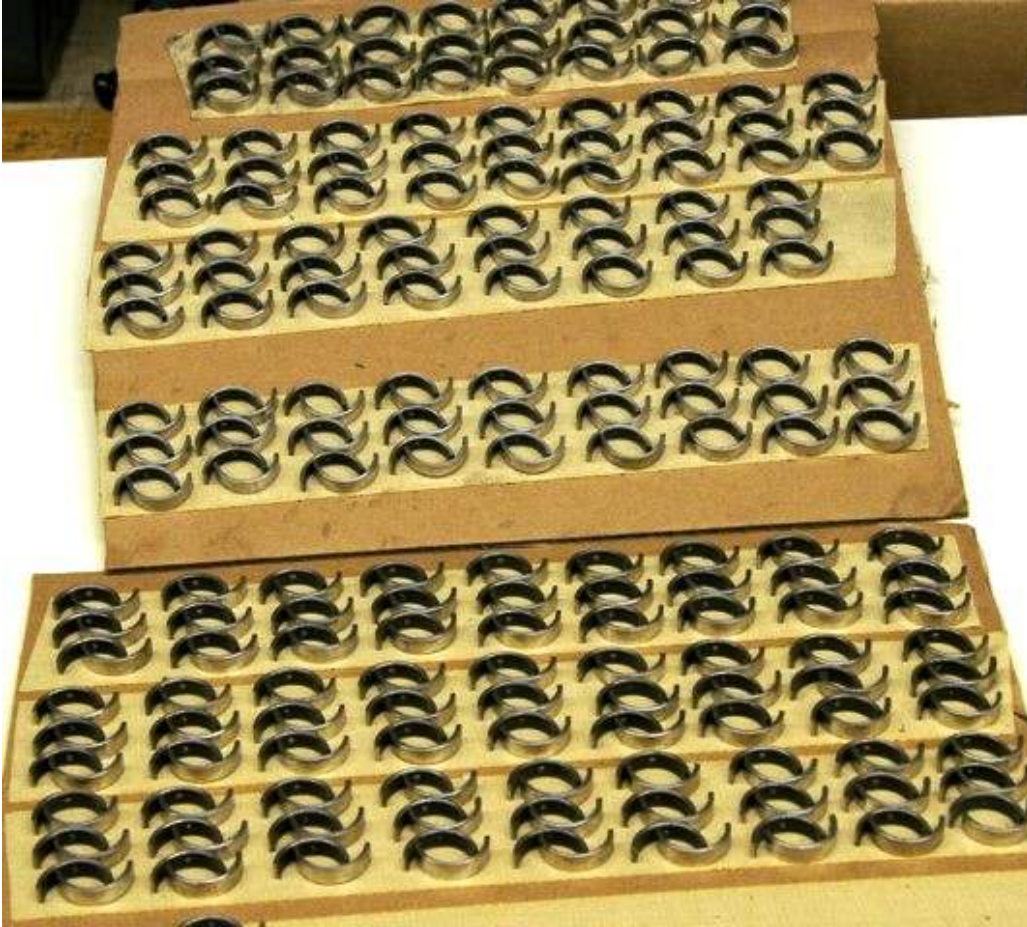
Pic #1

Another four weeks have gone by and a lot has happened. There is not so good news, good news, and great news. First, the not so good news - unfortunately, some things are out of my control. Just one example, shortly after my last update I was in the process of machining the main bearing inserts, when the CNC machining center decided not to turn on. After contacting the machine manufacturer and paying for two hours for a technician to come to my shop (\$145.00 per hour) it was determined that the voltage coming in to my facility was not correct. Without going into a long explanation, the electric company said it was not their problem, but should work with the machine manufacturer to solve the problem. Needless to say there is where the problem started. To make a long story short, almost 2 weeks later two isolation transformers, numerous lengthy phone conversations, and over \$2,200.00 spent, the machines are back in operation. When I say machines, I should also say that when I tried to run the CNC lathe on the same isolation transformer and it was discovered, much to my disappointment, the motor drive unit had been destroyed by the bad voltage. Unfortunately, it is impossible to get someone to repair the lathe and I had to spend my time to repair the machine. Without the CNC equipment in top operating condition, then it would be impossible to continue to make parts. As the saying goes "welcome to my world"! All was not lost during this time; there were other parts and components that needed my attention. Picture #1 is not "art deco" but rather finished main bearing inserts.

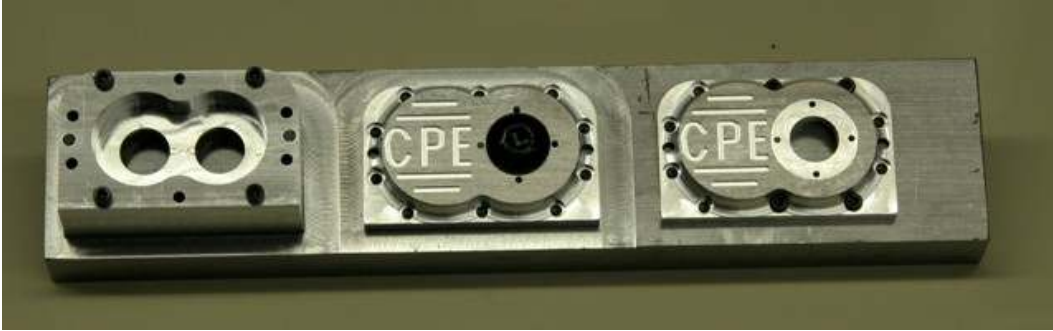
Pic #2

Although the main housing remains the same, the entire front of the supercharger had to undergo a radical change, as you can see from pictures #2 and 3. In the past superchargers the timing gears were exposed to the incoming fuel, which had 20% oil content for lubrication. Since the new engine runs on gasoline, the gears now had to be isolated with their own oil supply. After about two weeks of late hours and extensive CNC programming, I can say that it is finished. Over the past years I made several hundred superchargers with the exposed gears and did not have one failure, so I am very confident that the changes and modifications on the new supercharger will make it as reliable. There are 7 ball bearings, 3 oil seals, 3 "O" rings, and all covers are now "dowel pinned" for exact reference and alignment. You can see the difference in the front housings of the finished supercharger in pictures #4 and #5.

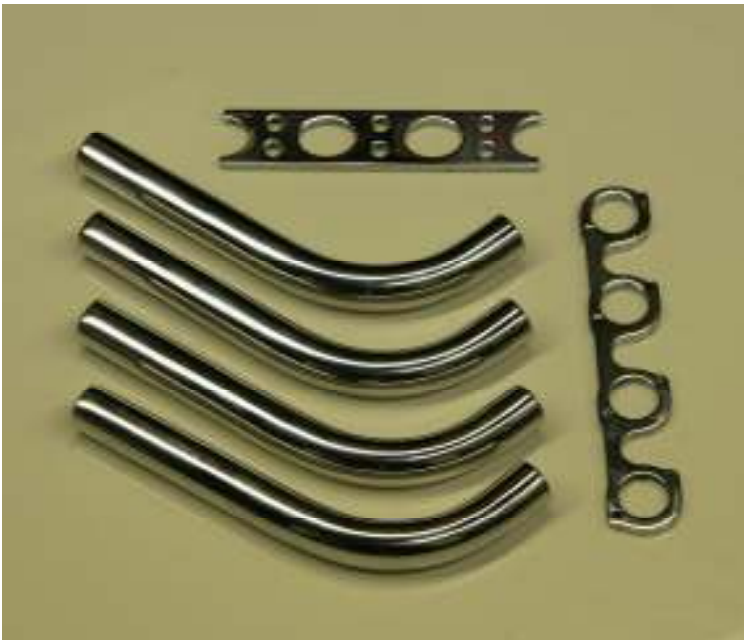
Pic #6

Picture #6 shows the new polished "Zoomie" header components. Notice the CNC header flange and spreader. (The engine will come stock, with the unpolished version).

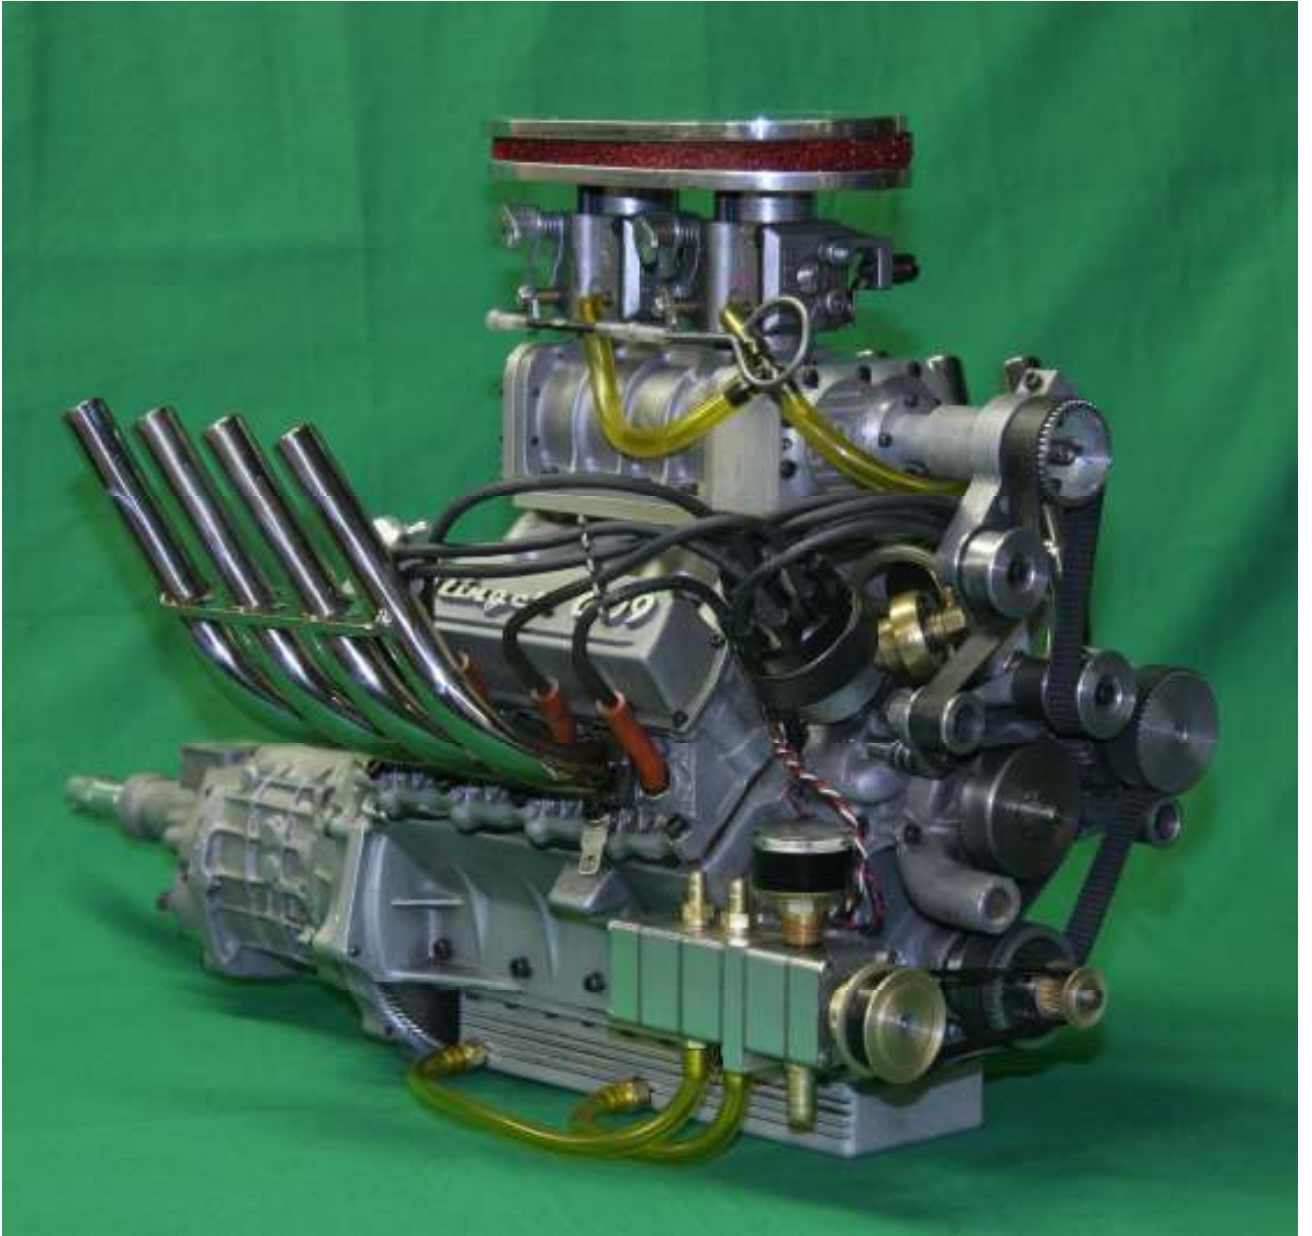
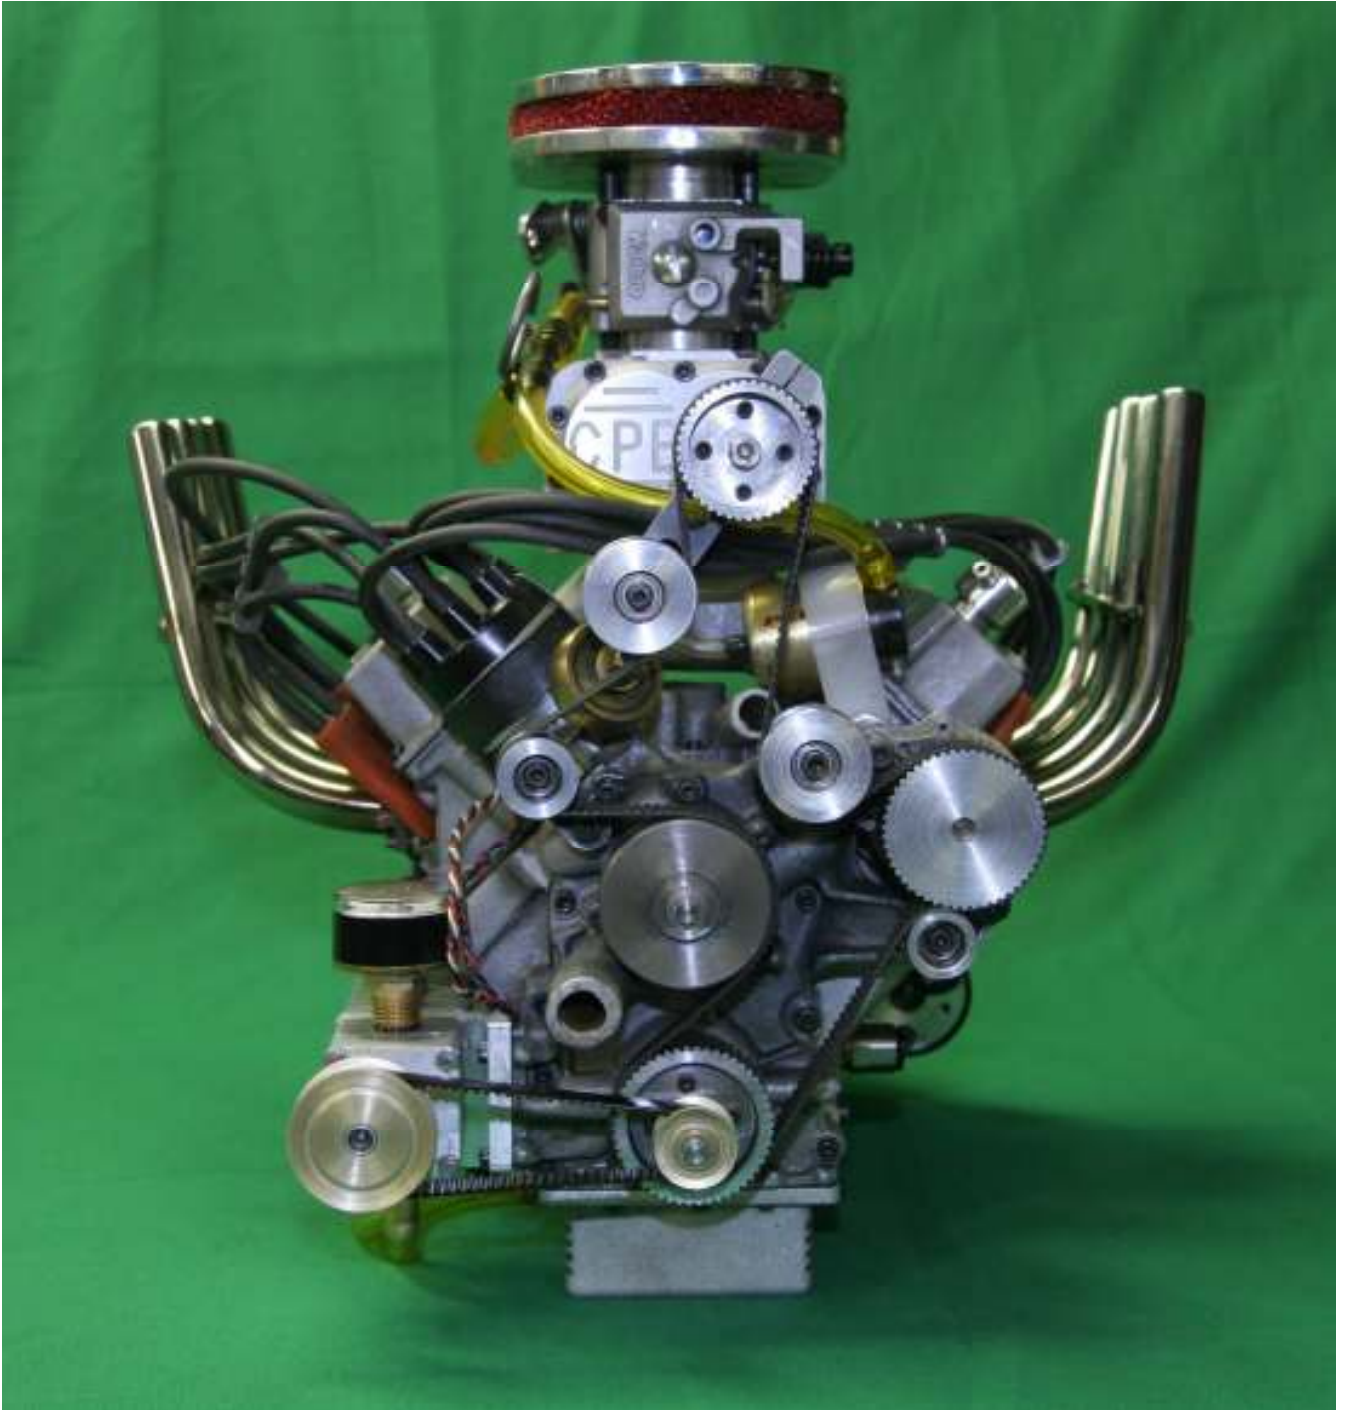
Pic # 7

Now for the great news, picture #7 and 8 shows the finished supercharged version of the Stinger engine. A lot of my current customers have asked what the finished engine will look like. The waiting is over. Although, I have not put it on the Dyno, I can say that it runs great!! No problems. None! Even the carb adjustments were simple. I will be posting a new video of the engine running in the very near future. The last two pictures also show the new Stainless Steel, polished "Zoomie" headers.
