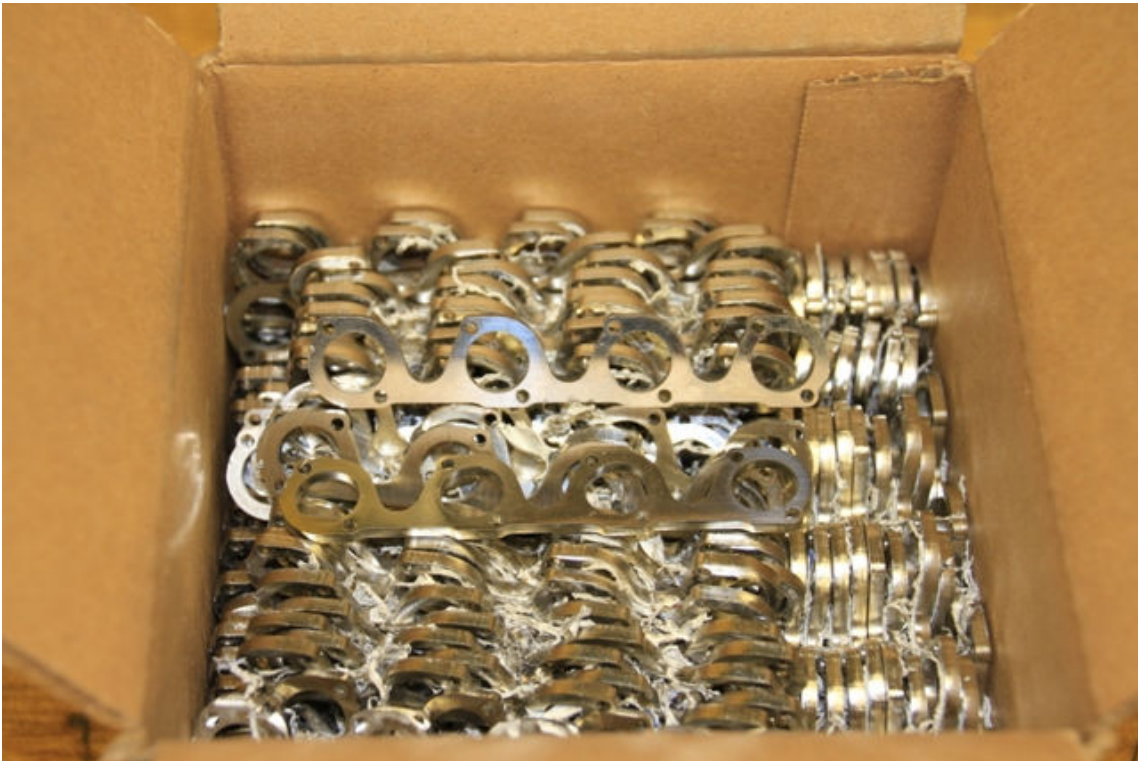
Pic #2

The other pictures are of the exhaust manifold flanges and exhaust pipe spreaders. Whereas this may look simple, it was quite a difficult thing to get done. Originally, these components were machined, but when the vendor raised the prices beyond reality, it made me take another look on how they could be made. I had planed to machine them myself, when a friend of mine suggested that I have them Laser cut. After a significant amount of time on the internet, I discovered a great company just a short distance from my shop. The prints were sent and after they were evaluated and modified, I had the material delivered, and about a week later, I have finished and polished components ready to be welded. The stainless steel exhaust pipe tubing is in stock and must be cut, polished, then bent to the exact radius.
