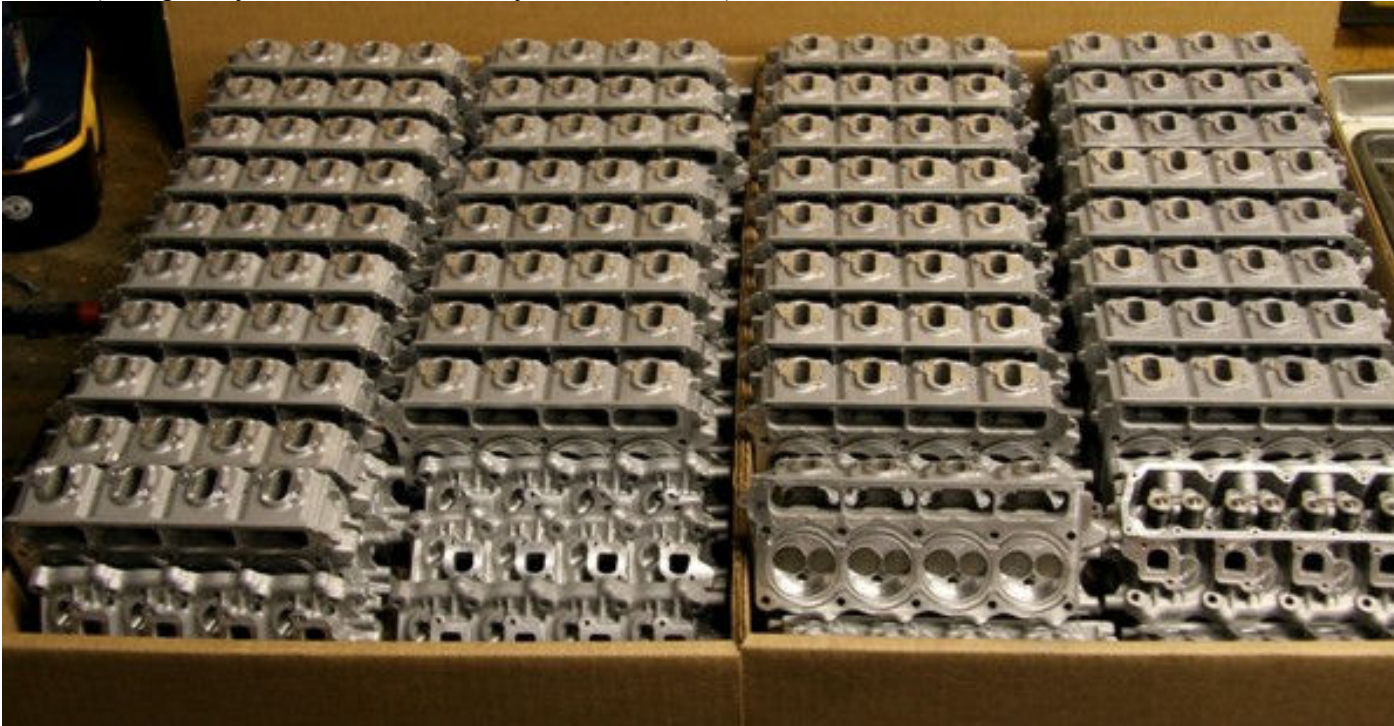
Pic #1 (Completely finished heads, ready for installation)

So much for the not so good news-as you can see from the pictures, the heads are completely finished and ready for installation. Finally! It started out with about 1 3/4 hours per head and now only takes an average of about one hour per head to lap the valves and assemble everything. Not setting the world on fire with this one! Once the valves were lapped, the heads were then thoroughly washed and inspected to make sure every valve seat was perfect. If there was the slightest imperfection then that valve was lapped a little more until the seat was perfect.

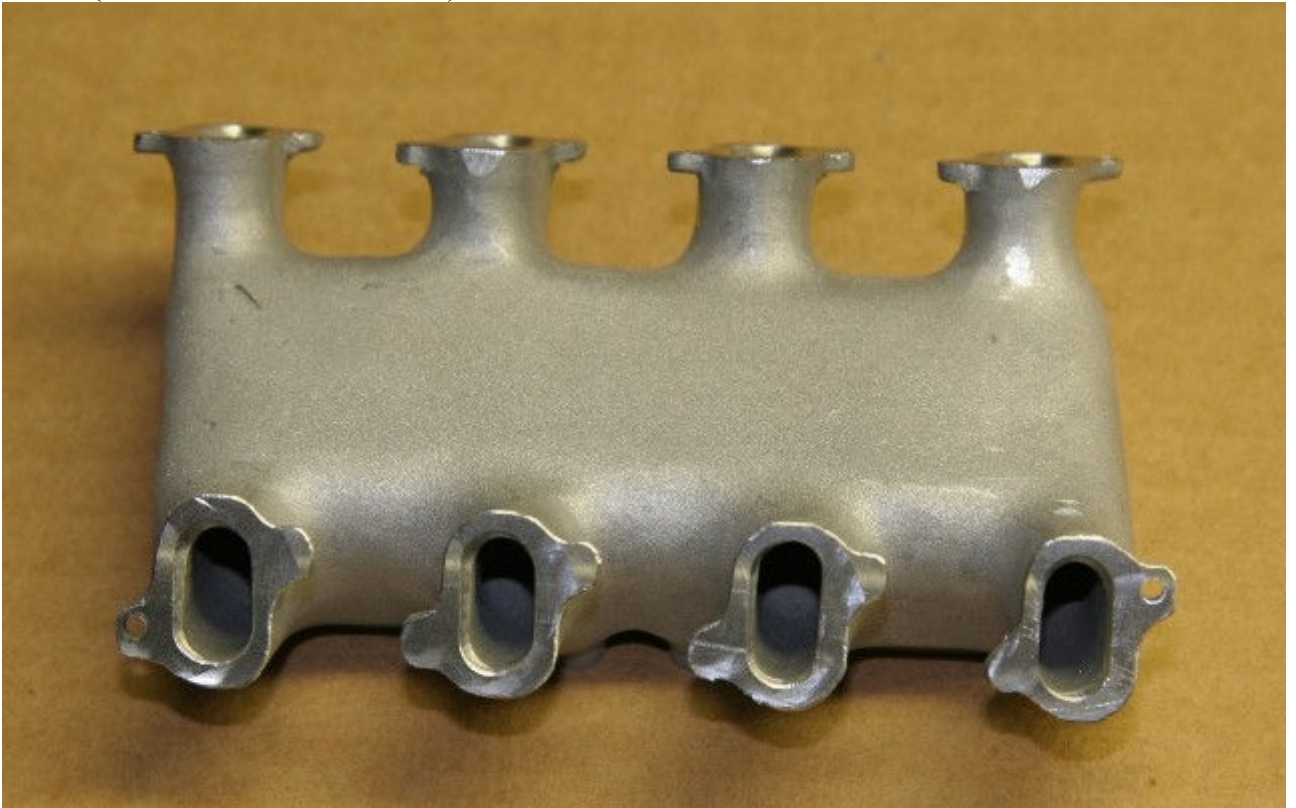
Pic #3 (Bottom on intake manifold)

As a matter of fact, the new castings are finished and will be sent to be heat-treated next week. The jig remains in the indexing fixture, the program has been written and proofed, and all that will be needed is to set all the tool offsets. If you look closely at picture #3 you will notice the intake runner seams to have what looks like a machining mistake or off-center. This is in all actuality was a significant find. When the jigs were made it is extremely difficult to get the core of the intake to match perfectly with the intake port on the head. For those of you who are into full sized racing you have heard the term “blueprinting”. If so, one of the critical areas is the mating of the intake manifold with the port on the head. A lot of time is spent to make sure that all surfaces align perfectly and the air-fuel has a smooth passage with no edges to inhibit the flow. Although not exactly like “blueprinting”, the concept is similar, in that I used a ball end mill to insure there is a very close alignment. Was it necessary, not really, and in all actuality no one would have ever known, but it was an area that took very little time but will result in a better performing engine. After all, isn't that the name of the game!

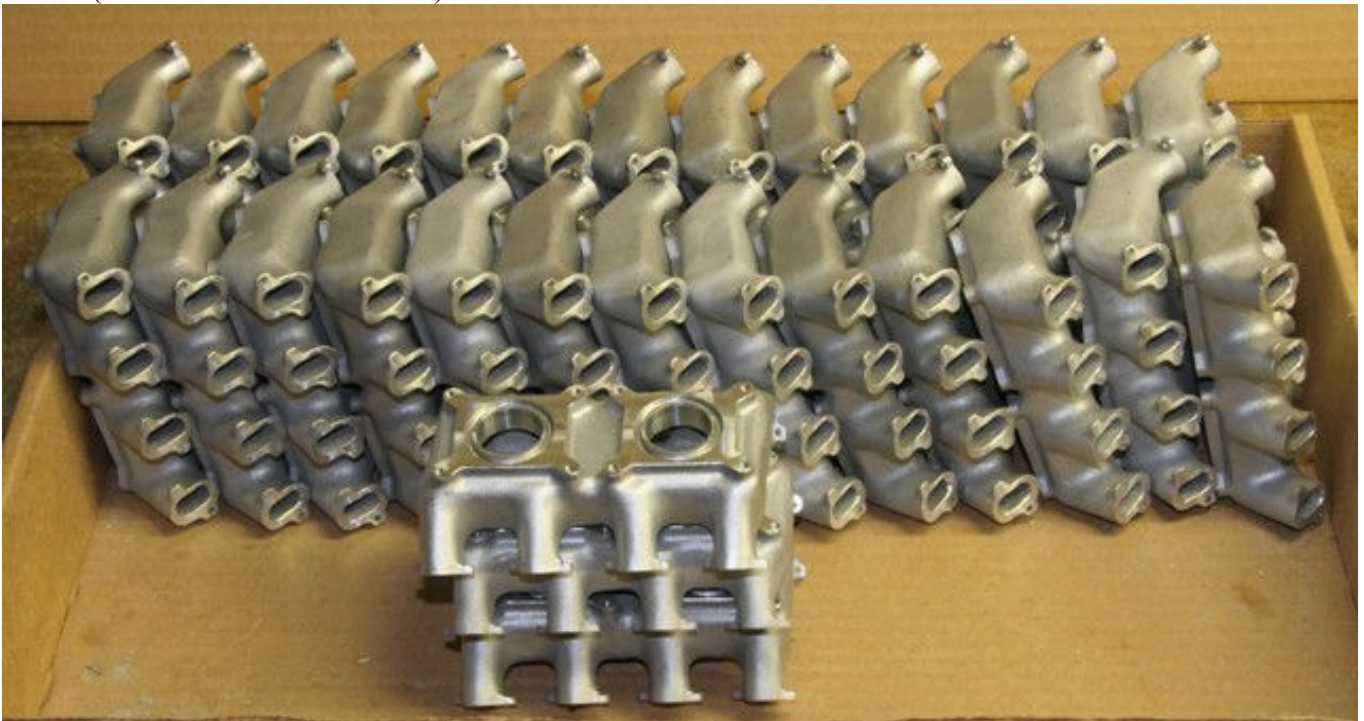
Pic #4 (Finished intake manifolds)

Because of the complexity and the limited amount of material on the castings for the intake manifolds, several were scrapped and I was forced to have some new castings made. This will not hold up production because by the time I am ready to install the existing intake manifolds, the new castings will be ready at the same time.
