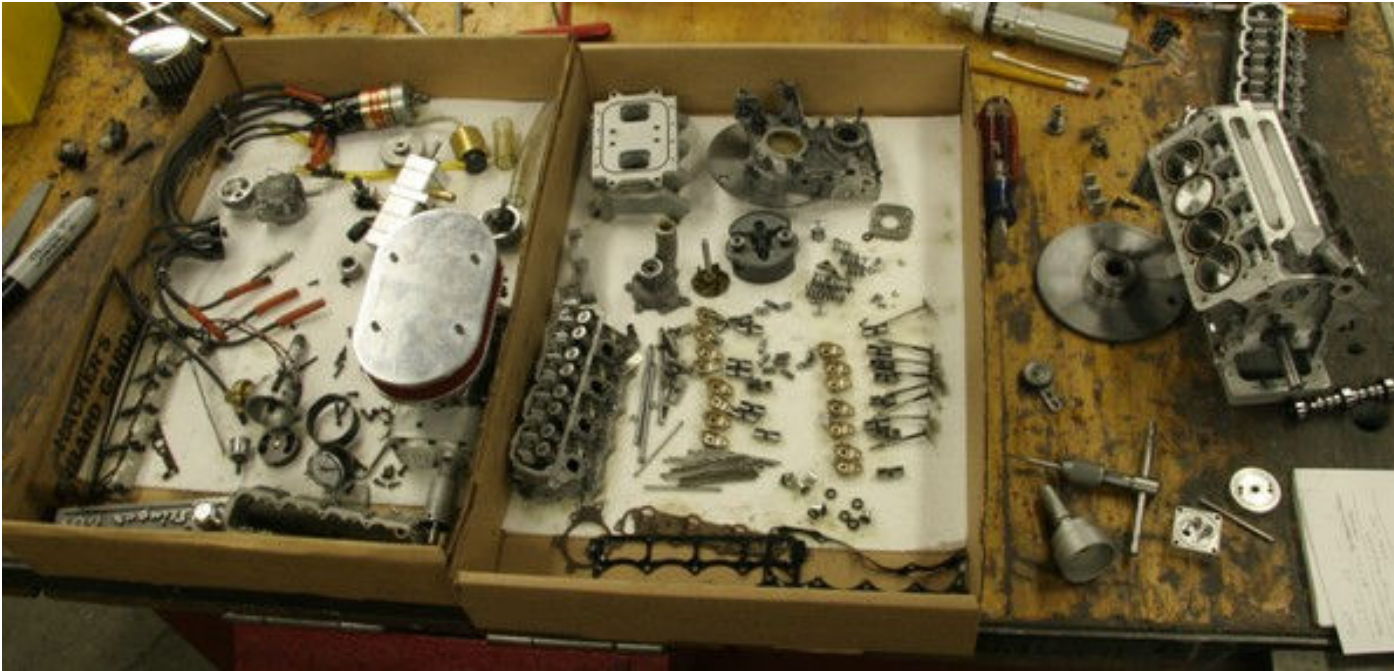
Pic. #1

Last week I spent about 8 hours disassembling the engine (Pic #1) and examining all the components for areas of concern or wear. I was totally pleased with what I discovered. There was not one item that show excessive wear, or fatigue. It was not necessary to remove the crankshaft and pistons. I did, however, remove the rod caps and main bearing caps to get a better look and the bearing inserts, and hear, once again, I did not find any wear that would be of concern. Pic. #2 shows the head with a small amount of carbon build-up around the exhaust valves, but in all honesty, I would have expected much more. The most amazing discovery was the condition of the pistons and cylinder walls. Pic. #3 shows the bank of cylinders immediately after the heads were removed. I did not touch or wipe down anything and feel that the picture speaks for itself. The camshaft was in perfect condition as can be seen in Pic #4. Even the lifters (Pic # 5) show almost no wear and the surface that contacts the camshaft is even more polished now than when I initially install them. I was looking for any signs of a single wear point which would have meant that the lifter was not rotating in the block. This is extremely important, because if the lifter does not rotate, the camshaft will show excessive wear, as will the bore that the lifter fits in. Every lifter looked exactly alike. No difference!
